Adani Total Gas Ltd.

Incident Investigation – DRS Fire Incident, Faridabad

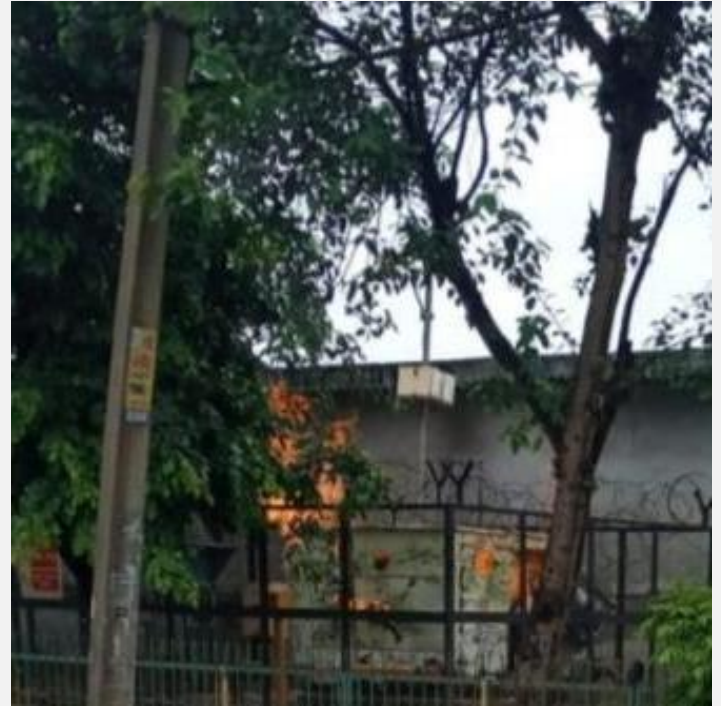
Overhead 11 kV HT cable fell over DRS Canopy resulting into Fire incident at our Faridabad GA (dated 1st Aug,2021).

The incident left no human injury, but entire DRS package burnt & got damaged. Due to looping of network customers were served without much interruption.

Fire lasted for 20 min. Fire brigade team was involved into extinguishing activity.

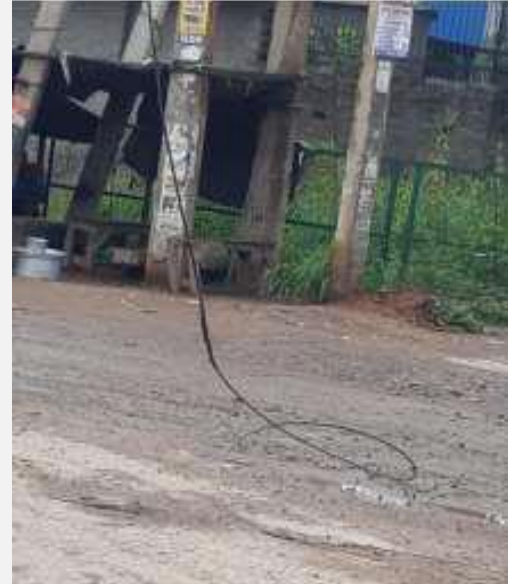
Fall of High-Tension Conductor:

- Fallen conductor has created phase to ground fault.
- Such condition does not establish rigid connection to ground and hence considered high impedance grounding.
- Fallen conductor is expected to swing till it settles down. Creating repeated arcing.

Protective Earthing:

- Earthing cable burnt due to heavy surge of 11KVA by electrical wire.
- **Electrical earthing's are designed for earthing of static currents and not for HT/LT cable protections.**

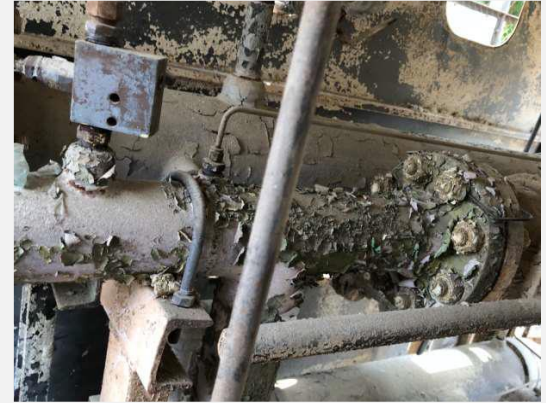
- Burnt bare conductor bonding with compartment body was evident inside the compartment.
- These burnt interconnections and gaps at some points suggest internal arcing (reverse fault current) at these locations which resulted into burning of these conductors .

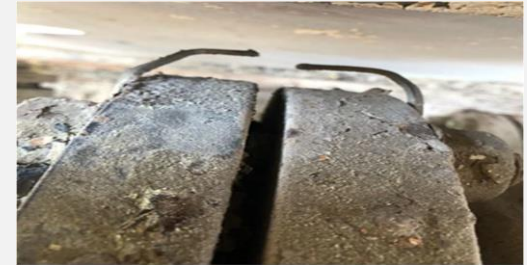
Paint burnt and peeled off:

- Arcing created by current flow through bonding wires and fault current flow in directions of bond grounds resulted in to rise in temperature of internal parts of compartment and ultimately fire at paint surfaces. (Contributing factor).
