Integrity of Old steel pipes

Ankleshwar – Valia Pipeline, Bharuch District, Gujarat

2nd Knowledge Sharing Workshop for CGD entities

14th February 2022

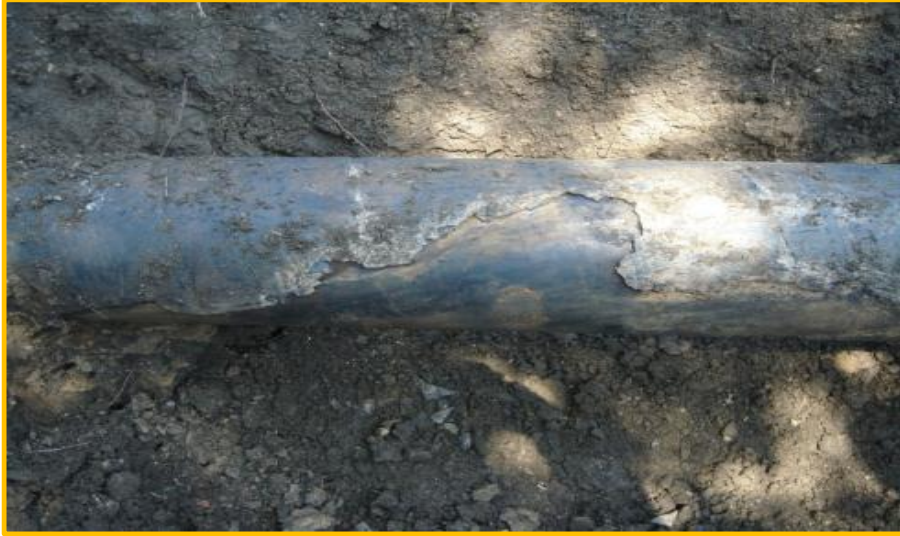
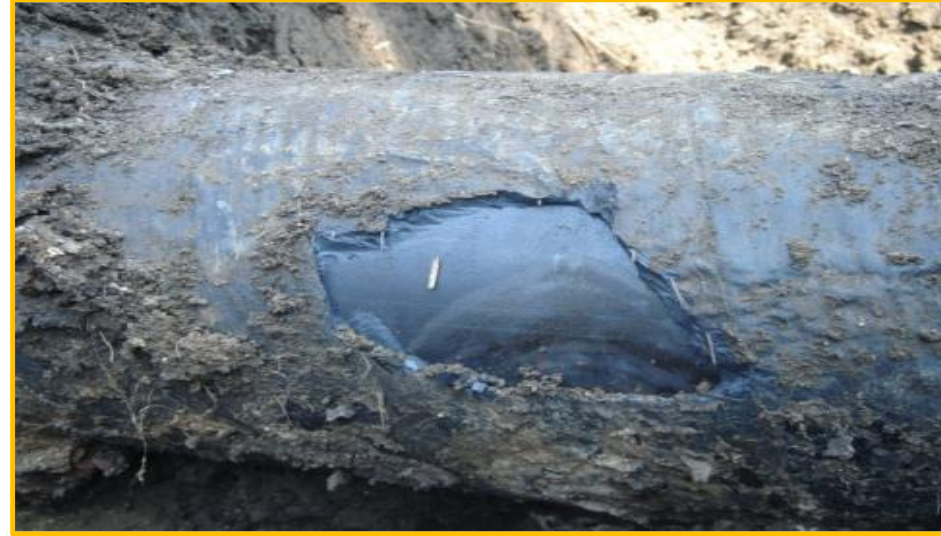
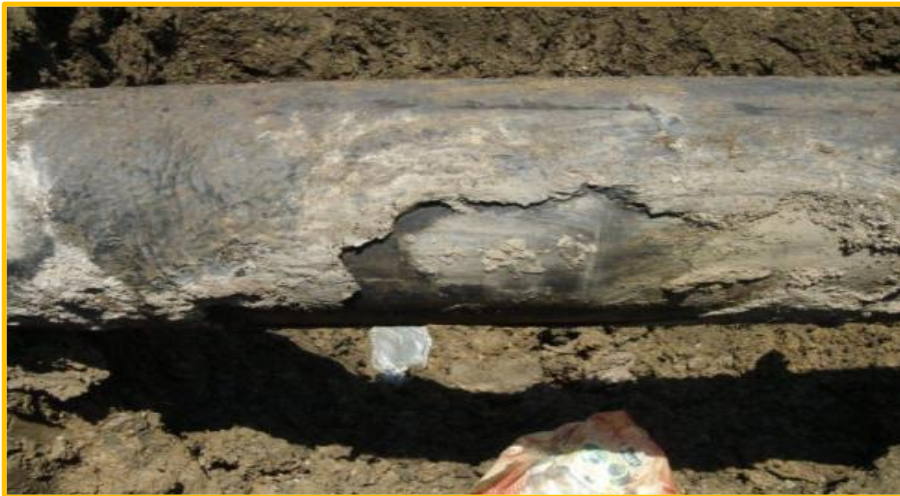
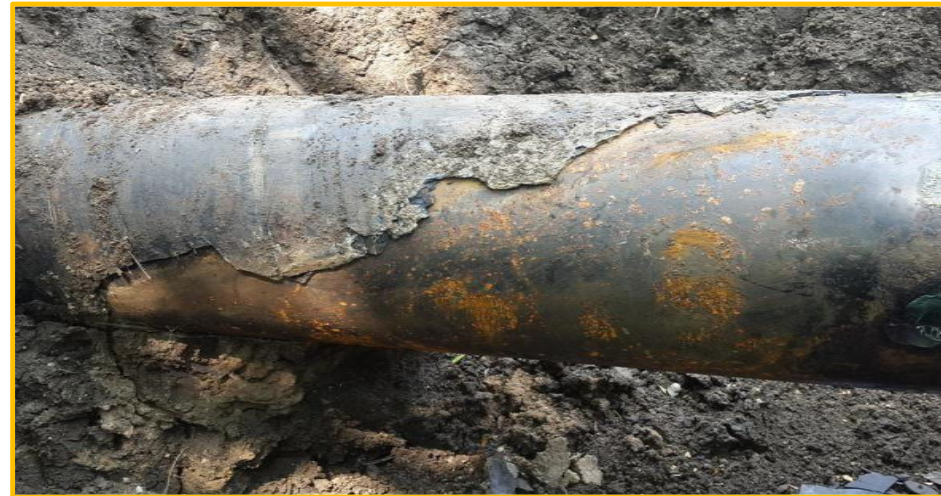
Photographs of Pipeline coating defects

Indirect Assessment	
DCVG Survey	Various coating defects were identified
	Current Range was High of 50~40V/25~30 Amps.
	ON/OFF PSP was ranging -1.30v /- 0.70v
Direct Assessment	
Bell Hole Inspection – (Digging)	CTE coating found brittle
	Hollow sound from CTE Coating
	Disbondment from bare steel pipe surface

Coal tar enamel coating was visually examined and was found to be brittle cum disbonded from Pipe Surface

- CTE coating –Field applied considered during construction in early '90s
- Soil Conductivity- Black cotton soil, part of the pipeline has rocky terrain
Coating capability of avoiding damage during the wet/dry cycling of black cotton clay soil.
- Industrial Chemical zone – polymers exposure may not shield the pipe from cathodic protection.
- Coating ageing- Life cycle ending

Option 3 i.e. Partial replacement of pipeline and partial coating refurbishment (8" Pipe Coating Refurbishment ~17 km (80%) and 8" Pipe section replacement ~4.20 km (20%))

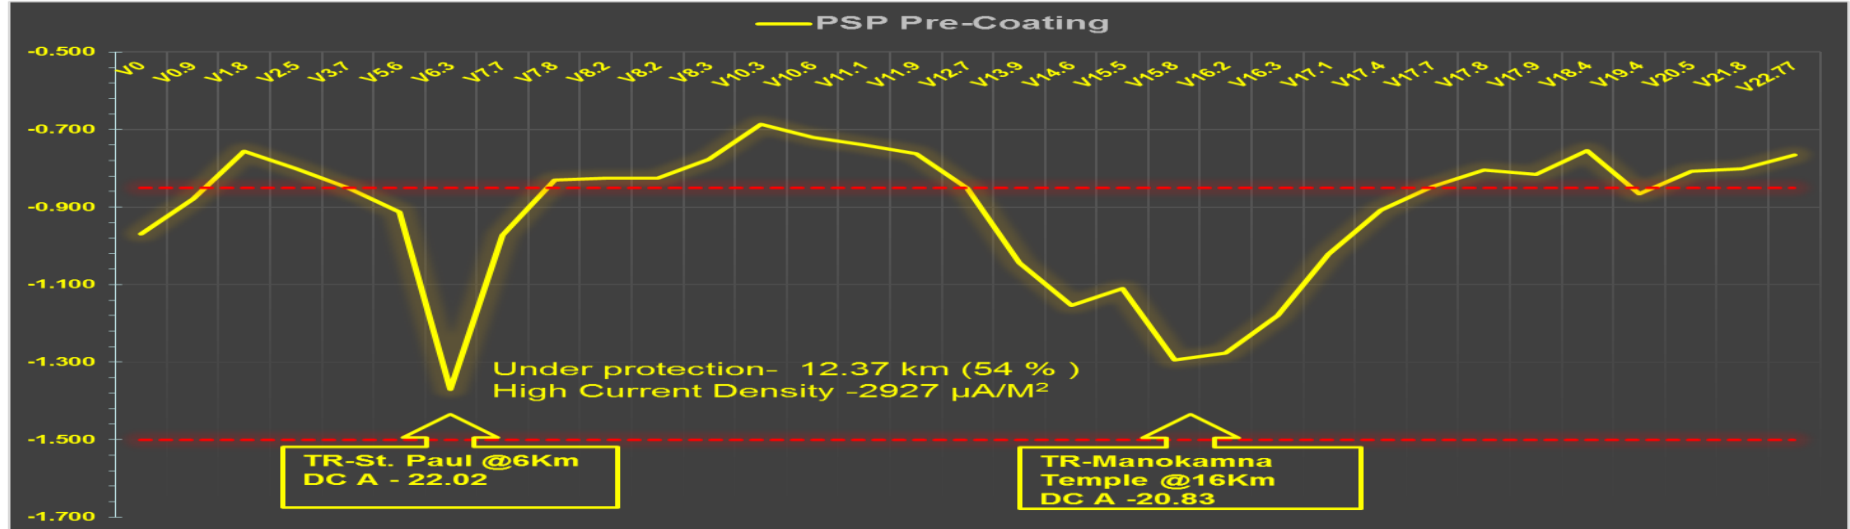
Before refurbishment & replacement

CP monitoring reports and DCVG reports indicated degradation & disbondment of CTE coating at many locations along the pipeline. Thus, threat to the pipeline integrity and challenge for continuity of gas supply.

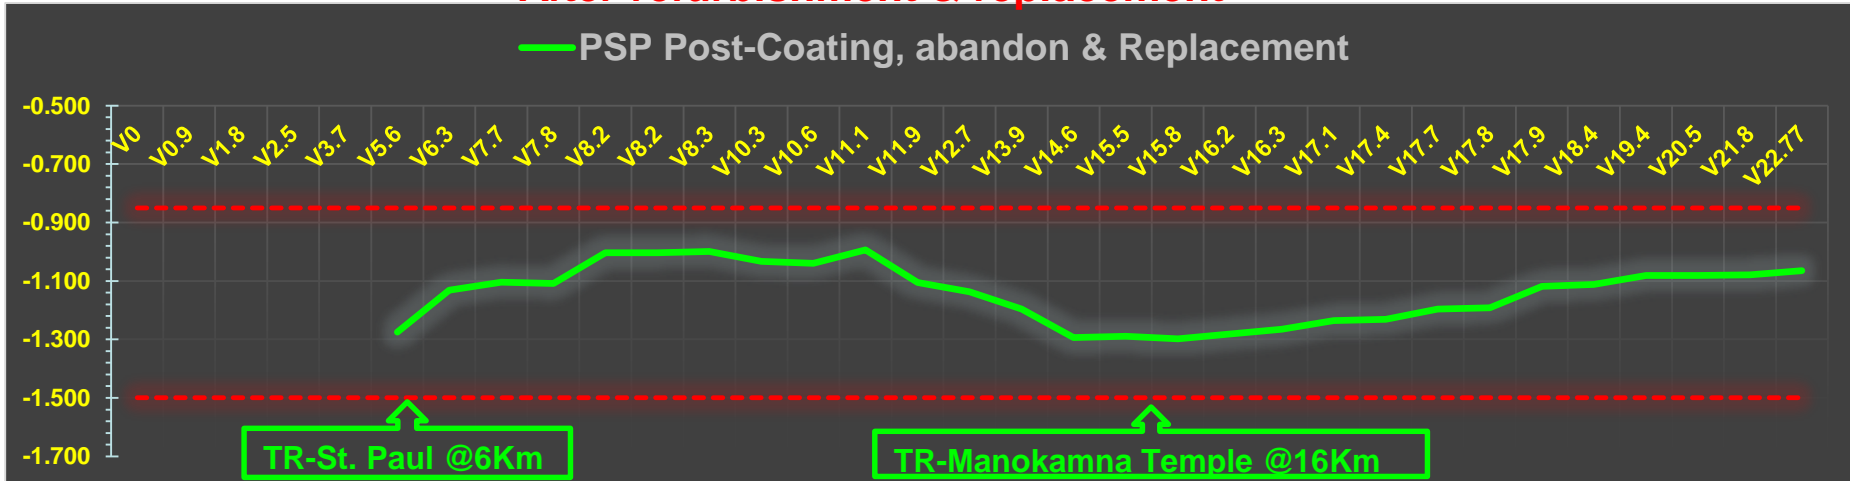
After refurbishment & replacement

CP protection achieved for 100% length
