GUJARAT GAS

**Learnings from recent incidents at CNG stations
2nd Knowledge Sharing Workshop for CGD entities
14 February 2022**

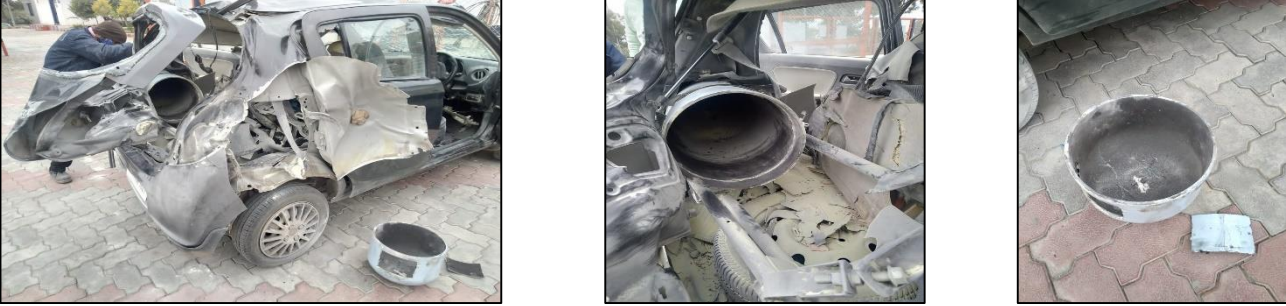
Incident Title	On-board CNG cylinder explosion, Sirohi		Date	09 Jan 2021
Incident description	<p>On 09/01/2021 at 08:58 Hrs., during CNG refueling in the on-board CNG cylinder of customer vehicle bearing registration number MH-14-HK-1821 at M/s Sagar Petroleum, IOCL-RO (Daughter Booster CNG Station), the on-board CNG cylinder exploded in two parts and also a rectangular section fitted on the cylinder body got blown off with high pressure gas. This resulted in to damage to the customer vehicle being filled. Minor injuries reported to the driver and a co-passenger (who were standing near the vehicle during CNG refueling) of the vehicle due to pieces of flying broken glasses of the vehicle resulting from the explosion. Injured persons were taken to the nearest hospital for treatment in OMC dealer's car. Vehicle was manually pushed to safe location by CNG Filler, compressor operator and other station staff.</p>

Key findings	<ul style="list-style-type: none"> • Filling of high pressure gas (Compressed natural gas) in the spurious cylinder leading to failure (explosion) of the cylinder body & rectangular plate fitted on the cylinder body. • The flying broken glass pieces due to cylinder explosion caused minor injuries to driver and a co-passenger of the vehicle. • Unauthorised alteration / modification of the on-board CNG cylinder by vehicle's owner compromising the integrity of the cylinder • Unsafe act by CNG vehicle driver & Co-Passenger since they were standing near the vehicle during CNG filling • Inadequate control to restrict passengers in CNG filling area 			
Photograph

Lesson Learnt	<ul style="list-style-type: none"> • Lessons learnt from the incident to be shared amongst CNG station staff <ul style="list-style-type: none"> • Continue safe practice of 'no passenger' in the vehicle during CNG filling in on-board CNG cylinder • Continue practice of verification of on-board cylinder test life validity • Be watchful for any gas smell or sound during CNG filling. In case of any indication of gas leakage or any unusual sound, immediately stop CNG filling • CNG refueling shall not be done if on-board CNG cylinder is observed spurious / altered / modified • Restrict people near the CNG filling area • Raise awareness amongst CNG customers to avoid installation of spurious / modified / altered on-board CNG cylinder • Communicate to owners/dealer of retail outlets to ensure compliance to safety requirements during CNG filling

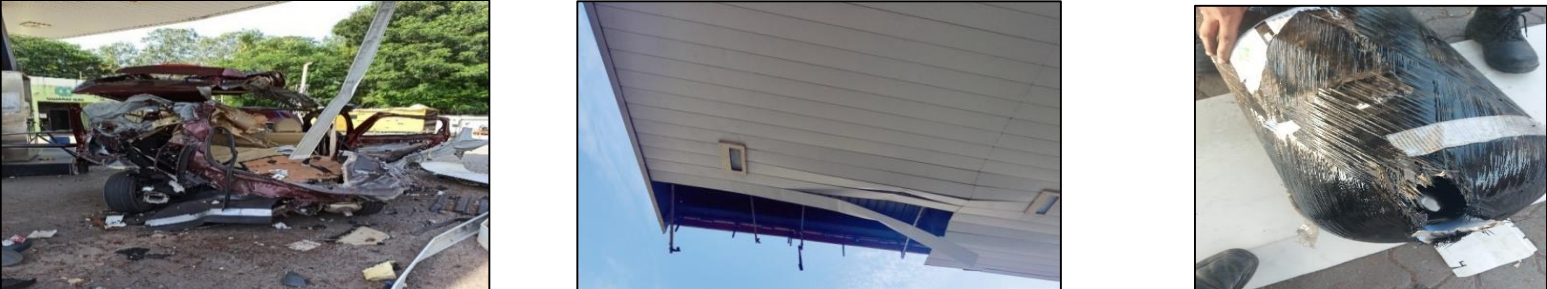
Photograph

Incident Title	On-board Type-4 composite cylinder explosion, Bharuch		Date	27 Oct 2021
Incident description	<p>On date 27.10.2021 at 23:55 Hrs., while refueling CNG in the onboard Type 4 composite cylinder of third party customer vehicle bearing registration number GJ 01 RX 3964 (Honda Jazz) at M/s GGL COCO CNG Station, Near GNFC Bus depot, Narmada Chokdi, Bharuch (Mother Online facility), the on-board cylinder exploded. This resulted in to severe damage to the customer vehicle being filled along with damage to CNG canopy over forecourt area. No injury reported.</p>			
Key findings	<ul style="list-style-type: none"> • Bursting (Rupture) of onboard Type-4 composite cylinder– During CNG refueling, the body of onboard Type-4 composite cylinder did not sustain the normal pressure (maximum 200 bar) of CNG being filled and got ruptured at two diagonally opposite points at bottom spherical portion of cylinder body. Rupture of the cylinder body led to propelling of the cylinder causing severe damage to the vehicle being filled and minor damage to canopy of the filling area. • The possible causes of bursting (Rupture) of onboard Type-4 composite cylinder body may be due to “damage to the cylinder during storage/transportation/handling/retrofitting” or “manufacturing defect”

Lesson Learnt	<ul style="list-style-type: none"> • Lessons learnt from the incident to be shared amongst CNG station staff & relevant stakeholders. <ul style="list-style-type: none"> • CNG refueling shall not be done if on-board CNG cylinder is observed type-4 composite cylinder till establishment of the root cause for the cylinder failure by competent authority. • Continue safe practice of ‘NO PASSENGER’ in the vehicle during CNG filling in on board CNG cylinder. • Driver of Vehicle must stay away from the on board CNG cylinder being filled. • CNG filler to note down the details of vehicle with on-board Type 4 composite cylinders coming for refueling. • Details of on-board Type 4 composite cylinder to be captured in CNG filler training module for creating awareness amongst all CNG fillers.
