## Case Study on Major Incidents

**Case Study No.:** PNGRB/Tech/2025/RO/ 10

**Incident Title:** Bursting of On-board CNG cylinder of customer vehicle at a CNG station

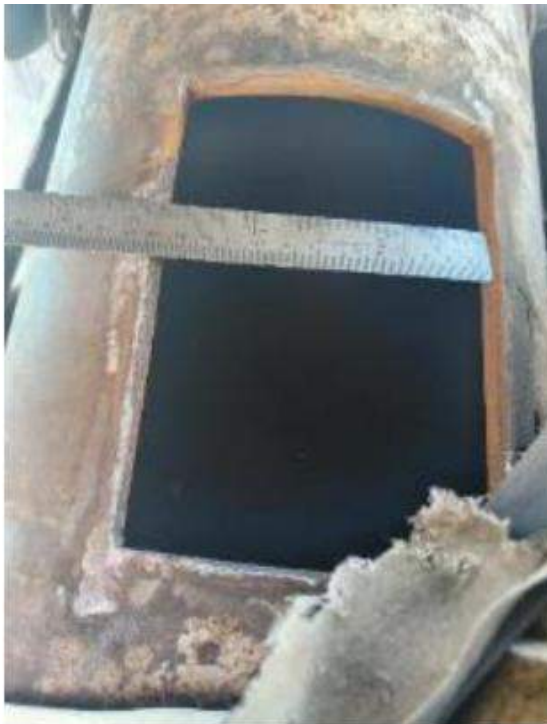
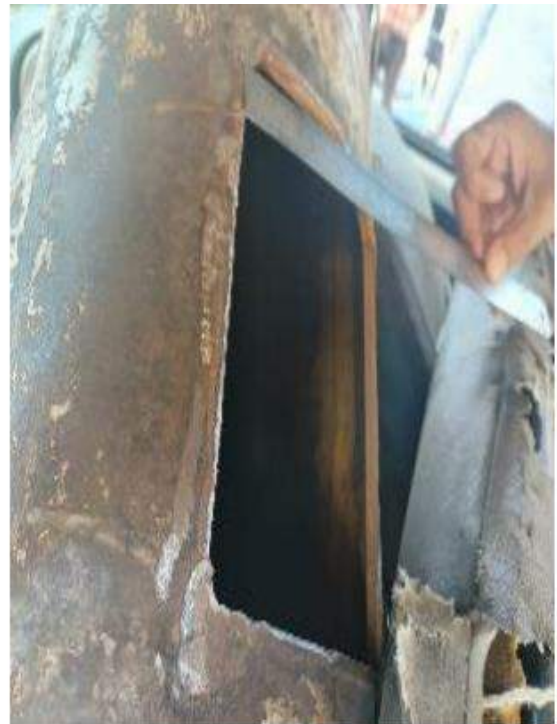
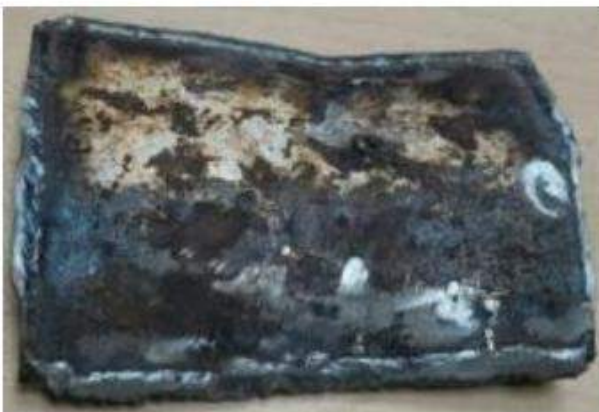
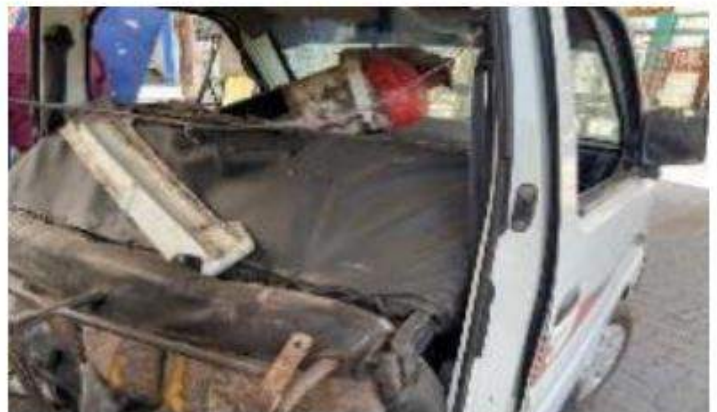
### Photos:

During the CNG refuelling in the on-board CNG cylinder of a customer vehicle (Vehicle Fuel Type - Petrol/CNG fuel), a rectangular piece (size 7.5" x 5.5") from the third-party on-board cylinder was blown off after bursting with release of high-pressure gas. The cylinder bursting resulted into severe damage to the customer vehicle being refilled. However, no other damage is reported to CNG assets at station forecourt area. No injury to any person reported. It is suspected that the detached portion of onboard CNG cylinder was intentionally cut and welded/fabricated on the cylinder and was positioned in such a way that it was not visible from outside. The incident was categorized as Major incident.

8. The on board CNG cylinder was cut (rectangle shape of 7.5" x5.5" size) and a plate of same size was welded on the cylinder. The rectangle slot surface in cylinder had brown coloured mild rusting and the cut piece has shiny grey surface. This suggests that the plate was welded onto the cylinder in recent past.

- 1. During CNG refuelling, the onboard cylinder got burst since a rectangular piece of cylinder was cut and welded / fabricated by local fabricator.
- 2. Un-authorized modification of the cylinder

1. Lessons learnt from the incident to be shared amongst CNG station staff & relevant stakeholder.
  - a. Continue safe practice of 'No Passenger inside the vehicle' during CNG refilling in on-board CNG cylinder

2. Raise awareness amongst CNG customers to avoid installation of modified / welded on-board CNG cylinder Customer Awareness campaign to include check list for self- verification including cylinder condition, especially at the time of change in CNG kit / ownership of vehicle.
