Case Study: **Internal Corrosion in a Gas Pipeline**

Nirmal Sharma,
Pipeline Integrity,
REPL

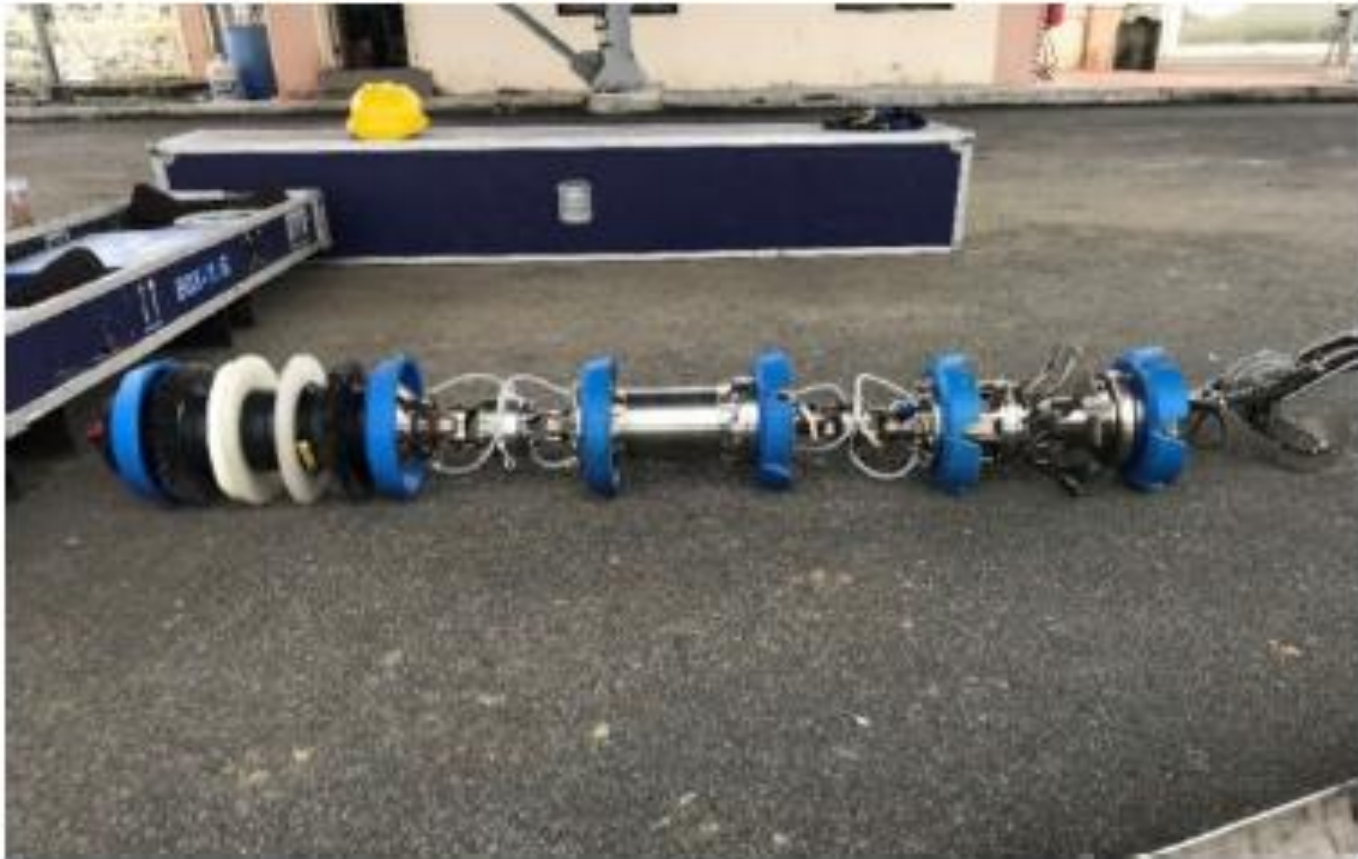
BMD Before Run

- ✓ 160 Kg quantity of debris in initial few cleaning runs
- ✓ More than 450 Kg of debris along with EGP run
- ✓ 300 kg more debris before next run (Cleaning)
- ✓ With MFL tool & after that 600 kg more debris received
- ✓ Till last run of the pigging, more than 1500 kg of debris had been received.

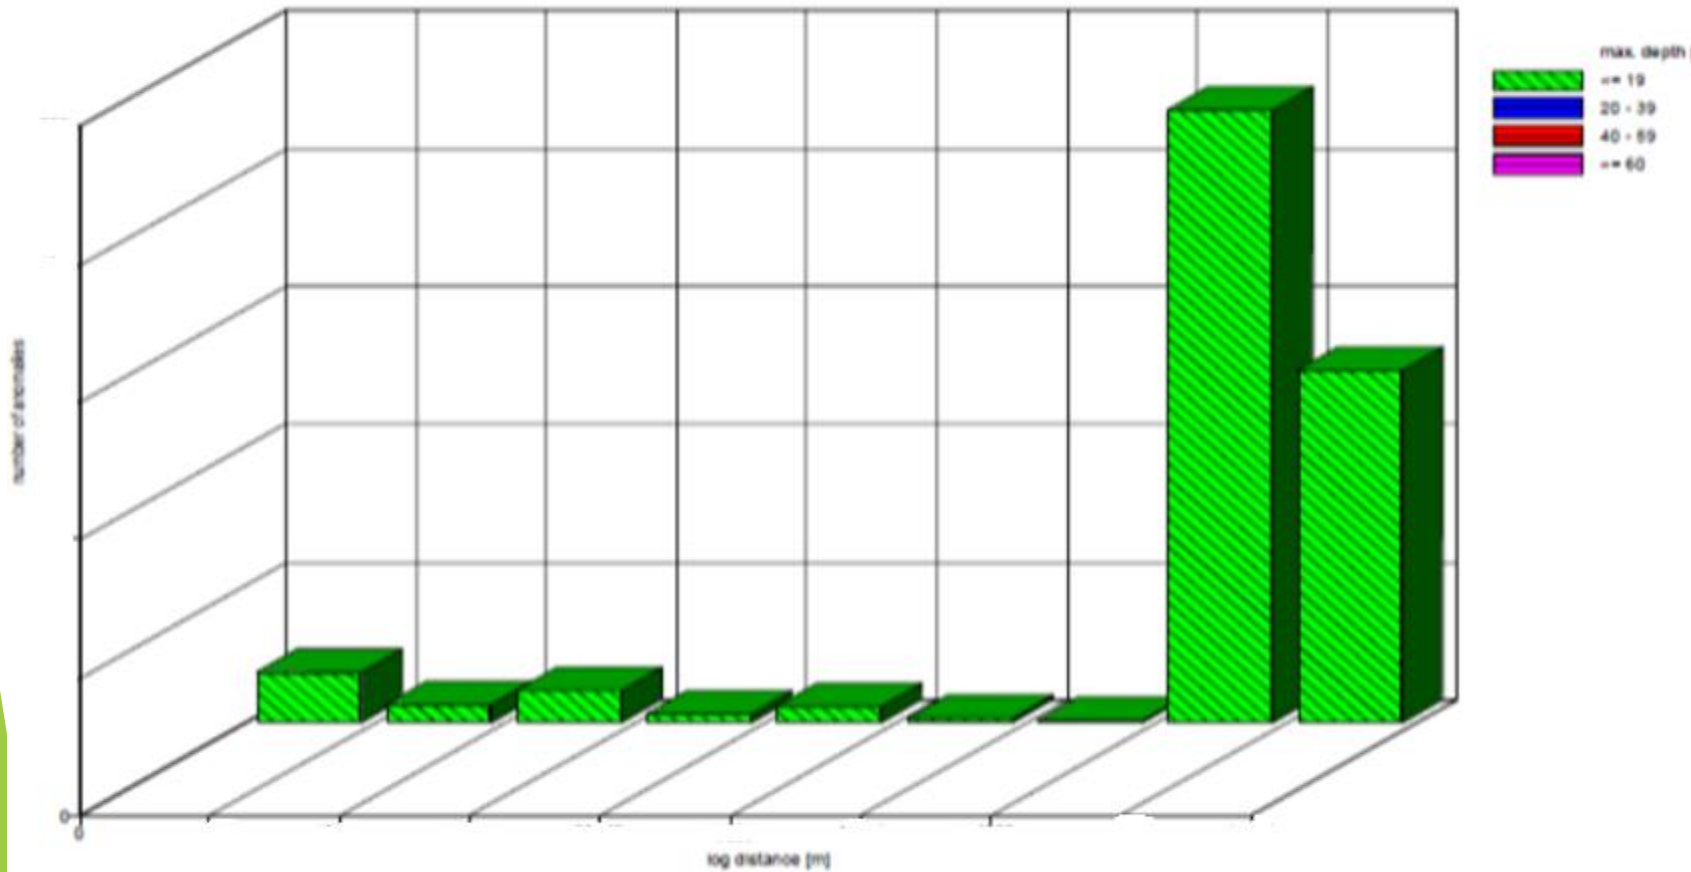
Anomaly distribution along the length of the pipeline

- ✓ 780 internal metal loss anomalies with wall loss exceeding the reporting threshold (10%).
- ✓ All defects having wall loss less than 20%.
- ✓ Maximum ERF found to be 0.9
- ✓ 90% of these defects were concentrated in last 20% of the pipeline section.
- ✓ 1st 80% length of the pipeline have only 10% of the total no. of the defect.
- ✓ 16 no of pipe joints (in 3 sections) have 660 (>85%) of the defects

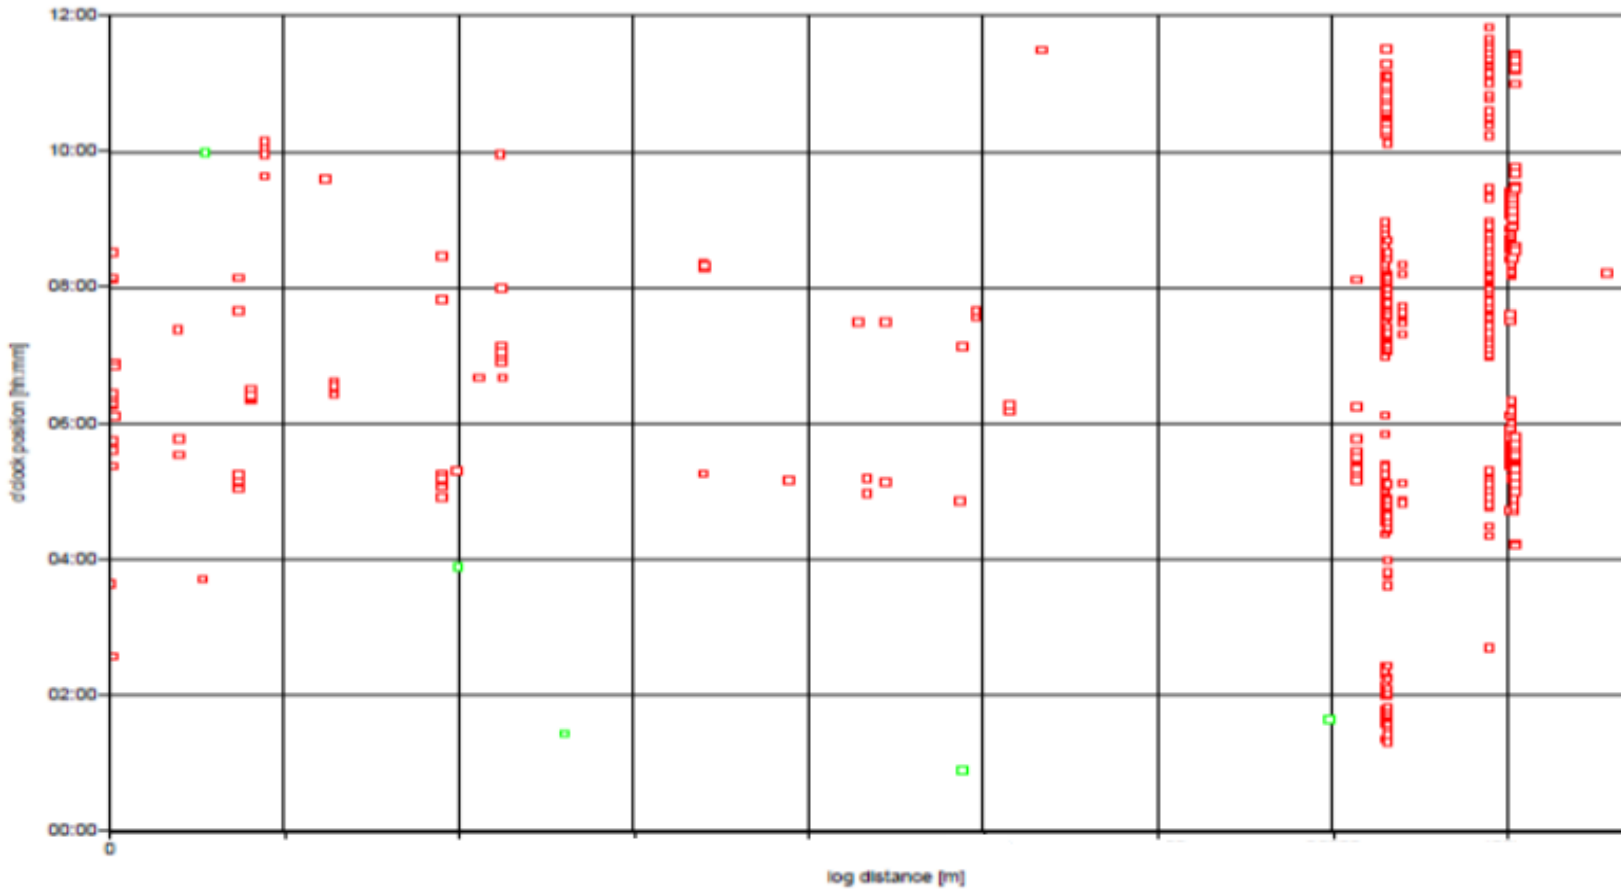
- ❖ Defects were randomly oriented all along the circumference & not at specific orientation-

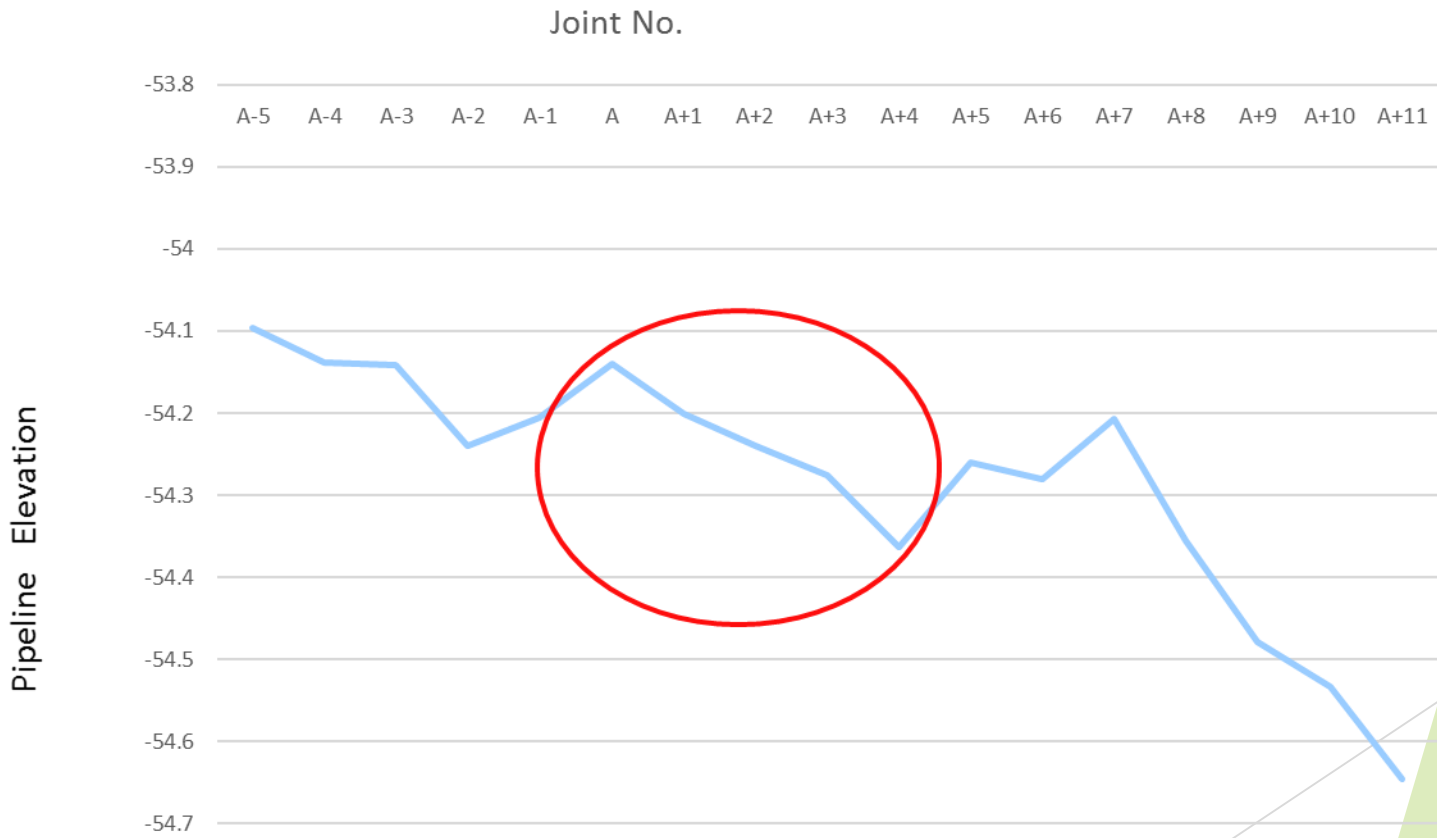
Section 1

Construction of this entire section at same time. However, different orientation of the defects suggests the corrosion might have happened possibly at pipe mill or storage yard.

Joint No	Total no of defects	Orientation of >80% of defects	Stringing	welding	lowering	Hydrotest
31170	143	7 to 8:30	Mar 16	Apr 16-Feb 17	May 16-Feb 17	Apr 17
31171	10	1:30 to 2:30	Mar 16	Apr 16-Feb 17	May 16-Feb 17	Apr 17
31172	9	10:30 to 11:30	Mar 16	Apr 16-Feb 17	May 16-Feb 17	Apr 17
31174	32	10:30 to 11:30	Mar 16	Apr 16-Feb 17	May 16-Feb 17	Apr 17
31175	11	1:30 to 2:30	Mar 16	Apr 16-Feb 17	May 16-Feb 17	Apr 17
31176	55	7 to 8:30	Mar 16	Apr 16-Feb 17	May 16-Feb 17	Apr 17

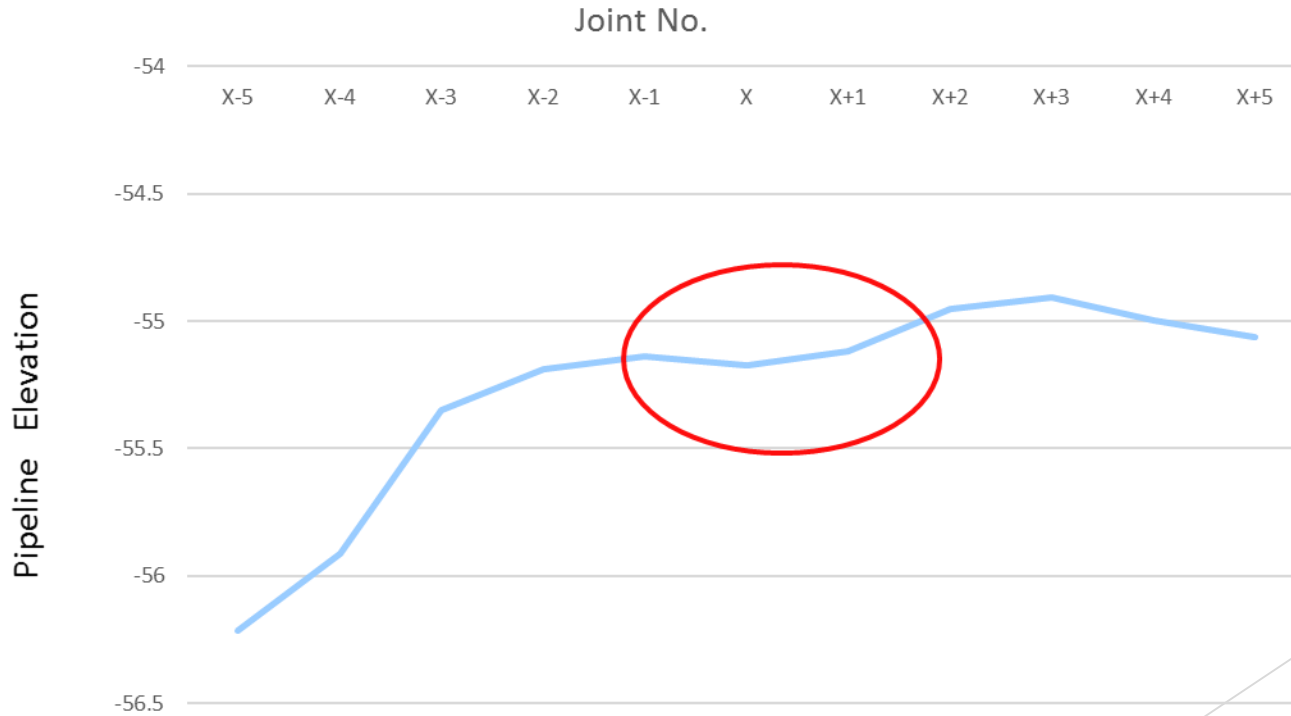
Joint No	Total no of defects	Orientation of majority of defects	Stringing	welding	lowering	Hydrotest
33820	156	4 to 5, 7 to 9 & 10 to 11	Mar 16	Apr 16-Feb 17	May 16-Feb 17	Apr 17
