THIRD PARTY DAMAGE OF DVPL-I

- Emergency Management & Restoration

Location : Noida
Date : 15 June 2022

GAIL India Limited

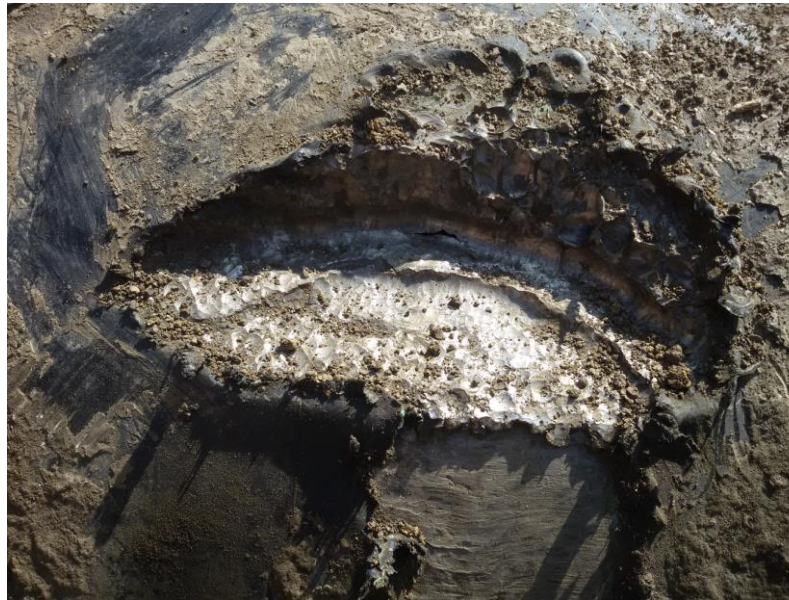
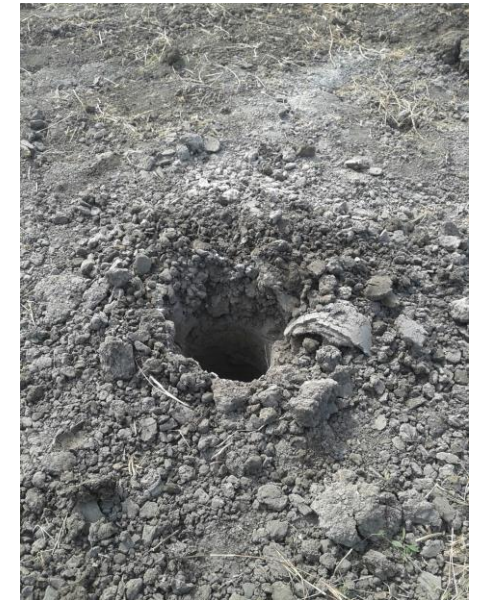
- GAIL has constituted a committee for the root cause analysis.
- Committee has made following observations upon detailed analysis of the incident
 - ✓ It was evident that the damage to the pipeline had been caused by a mechanical device like a boring excavator of 06" to 08" size.
 - ✓ It seems that the operator is unaware of the presence of a buried pipeline.
 - ✓ Incident has happened in odd (early morning) hours

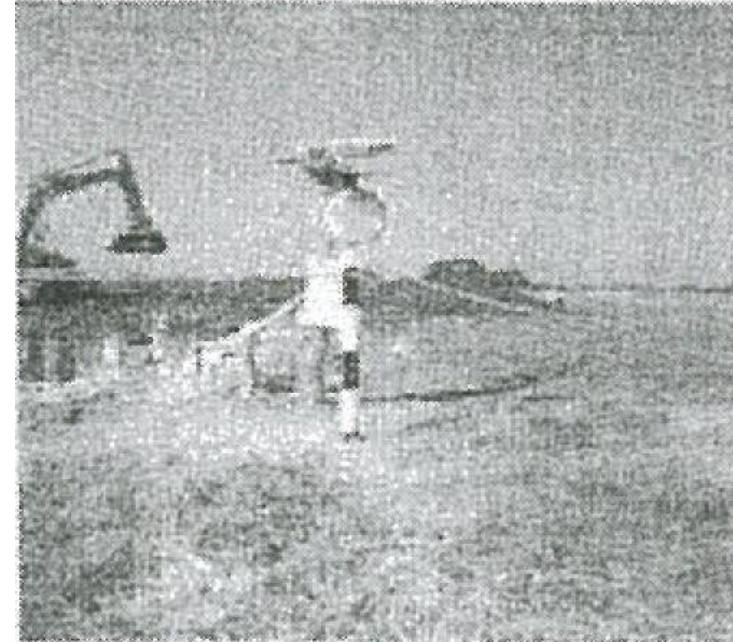
- ✓ Land owner has given the land on lease to a third party and they have not informed the borewell operator about the presence of pipeline.
- ✓ Boring has been done with out ascertaining the exact location of pipeline (by contacting GAIL) even though the direction cum warning marker is available in the vicinity of the incident location.

- Committee has concluded that the Negligence of the third party and borewell operator are the probable causes of incident.
