# PNGRB KNOWLEDGE SHARING WORKSHOP 2023

## CASE STUDY ON SR LINE LEAK IN CDU-III UNIT OF VR

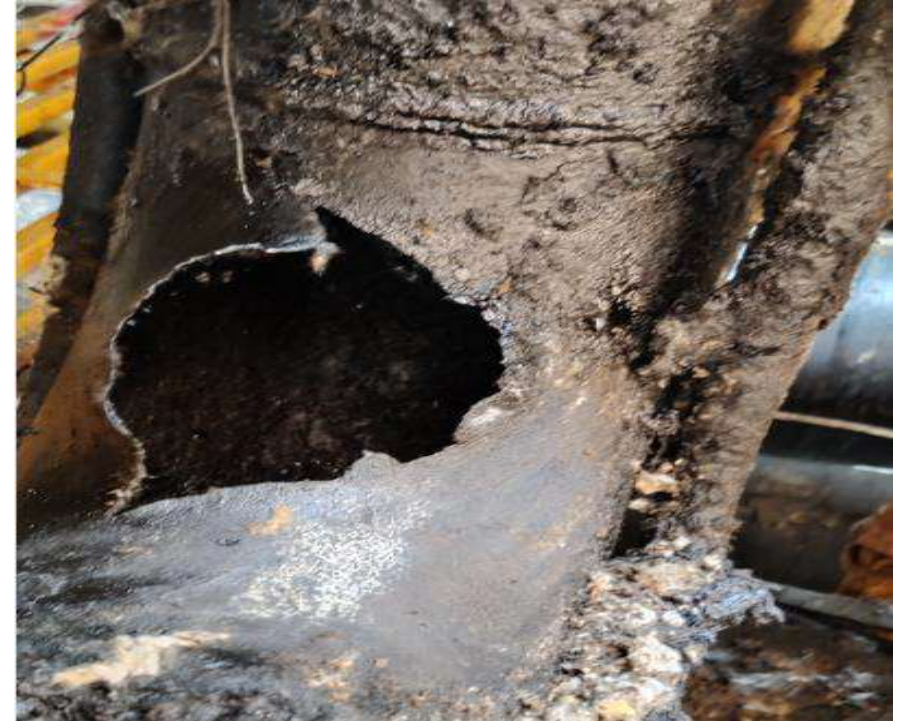
- During flushing of Vac Column bottom circuits, leakage of Flushing oil observed from one of the 6” elbow on SR (Short Residue) pump discharge line, upstream of the Pre-Heat Exchangers.
- Upon Insulation removal a hole of about 3” dia size found on the inner arc of 6” elbow.
- Mechanical failure of the elbow caused spillage of SR on grade level and deck 1 of TS
- Spilled SR caught fire due to auto ignition (SR temp 350 deg. C and auto ignition temp 280 deg. C).

**6” SR Line ruptured hole in elbow – seen after insulation removal**

- Metallurgy of the failed elbow as per Positive Material Identification (PMI) was found to be Carbon Steel (CS) instead of Alloy steel (P5 metallurgy-design spec).
- 100% PMI was carried out for the entire SR circuit during the previous unit T&I (2016). Two adjacent elbows on the SR pump discharge line were identified as CS instead of P5 metallurgy
- Localized corrosion of CS metallurgy resulted in thinning and failure of the subject elbow.
- Reason of localized corrosion is attributed to combined effect of high temp sulfidic corrosion and naphthenic acid corrosion.

- SR leak from the failed CS elbow and subsequent auto ignition.
- The material of construction of the failed elbow (CS metallurgy) does not meet the intended design specification of P5 metallurgy required for high temp and high corrosive service (SR).
- The rupture opening of the CS elbow occurred due to severe thinning caused by localized corrosion.

- The said two CS elbows were installed by mistake during Projects execution in 1999.
- During 2016, two separate isometrics were used by PMI and UTG agencies. Subject two elbows were identified as CS and marked on the PMI isometric.
  - A different set of two adjacent elbows were inadvertently marked while transferring from the PMI isometric to UTG isometric and attached with Inspection recommendation.
  - Wrong marking resulted in replacement of two P5 metallurgy elbows instead of identified CS elbows. One of these CS elbows failed leading to the subject incident.

- Revised Inspection SOP is put in place to ensure usage of correct metallurgy at fabrication stage and during repairs.
  - Implemented Four stage PMI checks: 1) At Vendor site by HPCL TPI; 2) At Warehouse; 3) At Fit-up stage and 4) Before Hydro test.
  - PMI and UTG related Inspection recommendations are issued with separate isometrics.
  - Joint certification by Inspection and Executing department is established to ensure correct metallurgy usage at original fabrication/replacement stage.
- Integrity operating windows (IOW) for critical circuits are developed and implemented in line with API RP 584.
