Knowledge Sharing Workshop on Petroleum Refineries by PNGRB & HPCL

CASE STUDY ON INCIDENT AT ISOM UNIT OF IOCL-HALDIA REFINERY

Visakhapatnam, 27th February 2023

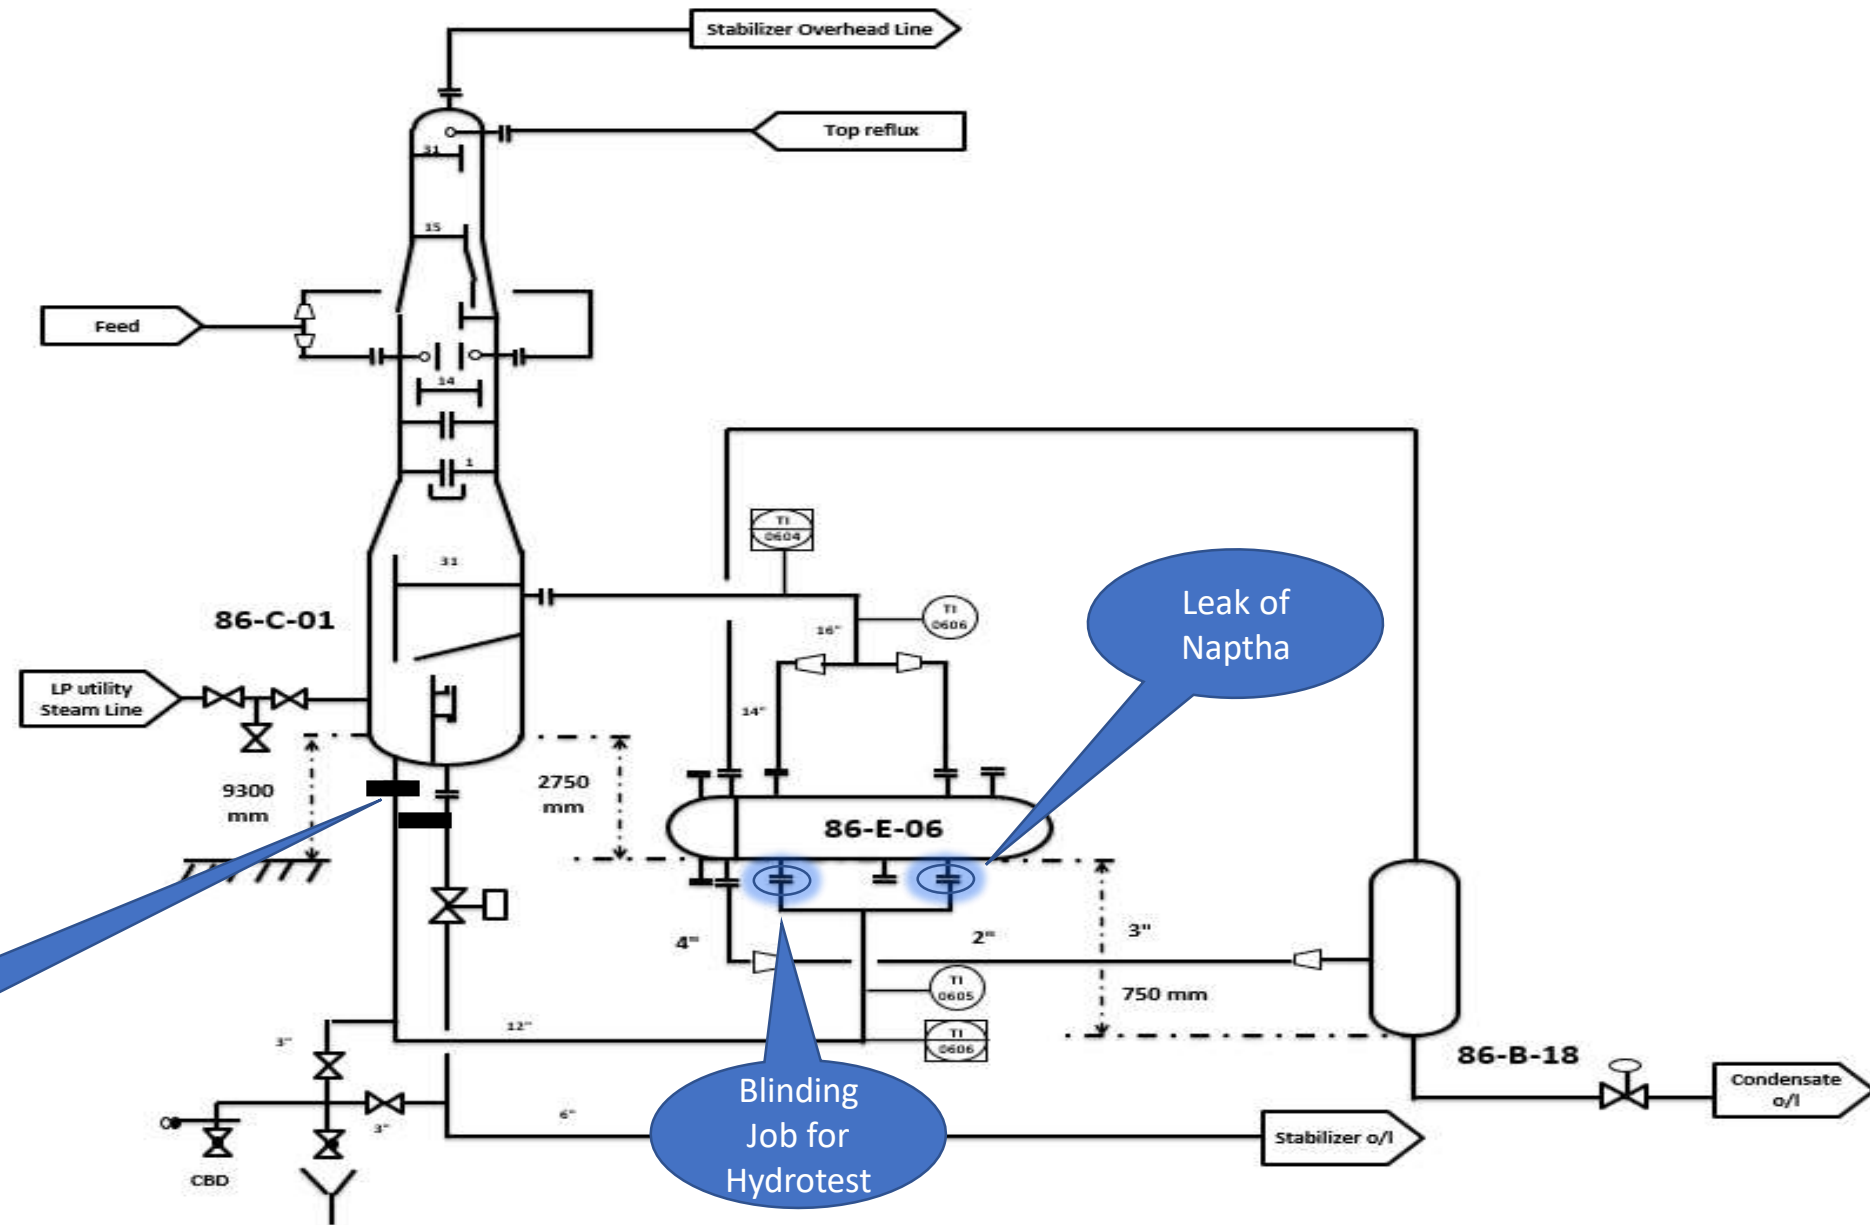
SCHEMATIC DIAGRAM OF THE STABILISER & REBOILER

Blinded

Leak of Naptha

Blinding Job for Hydrottest

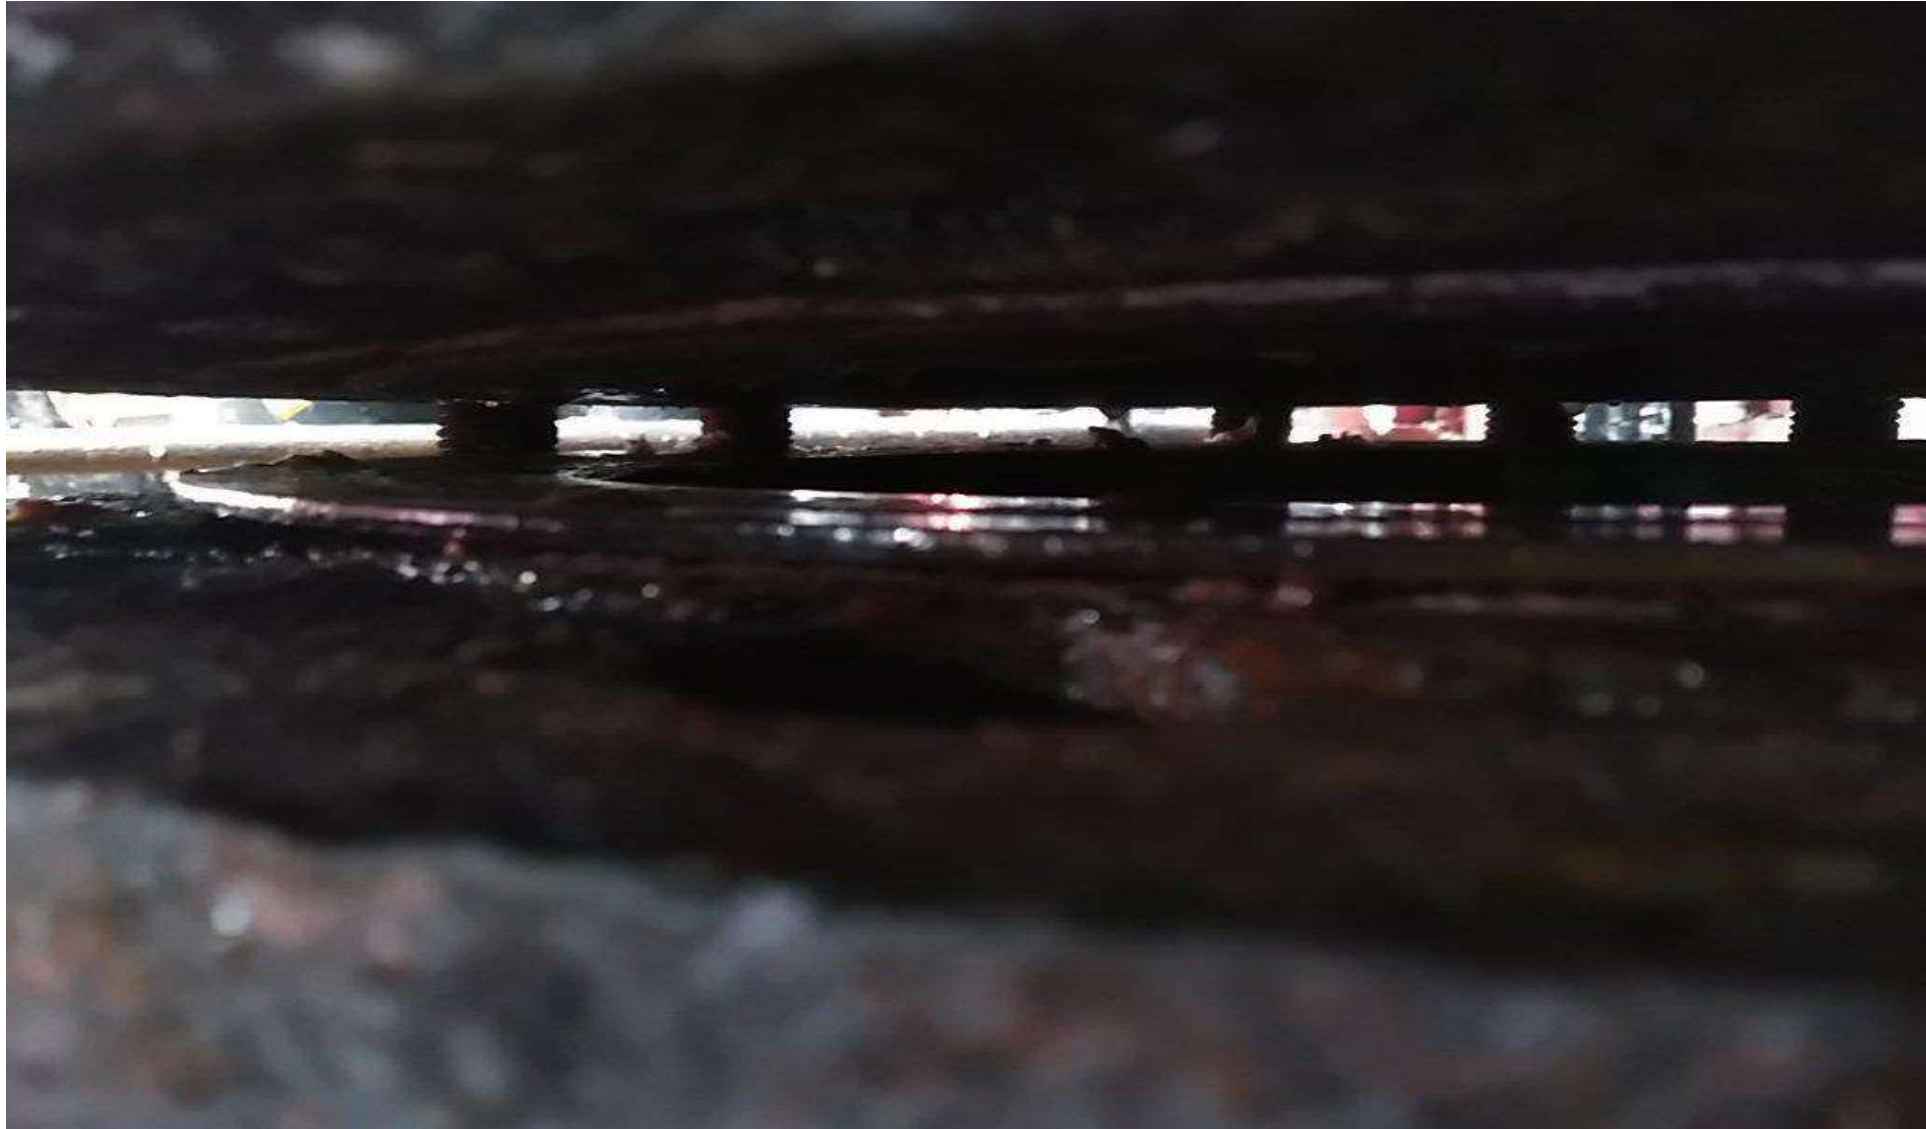
PHOTOGRAPHS FROM INCIDENT SITE- Reboiler inlet flange

- Spillage of hold up Naphtha from the reboiler inlet flange during flange opening for blinding and simultaneous hot job in the immediate vicinity led to the explosion followed by fire.
