# Incident Investigations

## Key Findings and Learnings

**Oil Industry Safety Directorate**

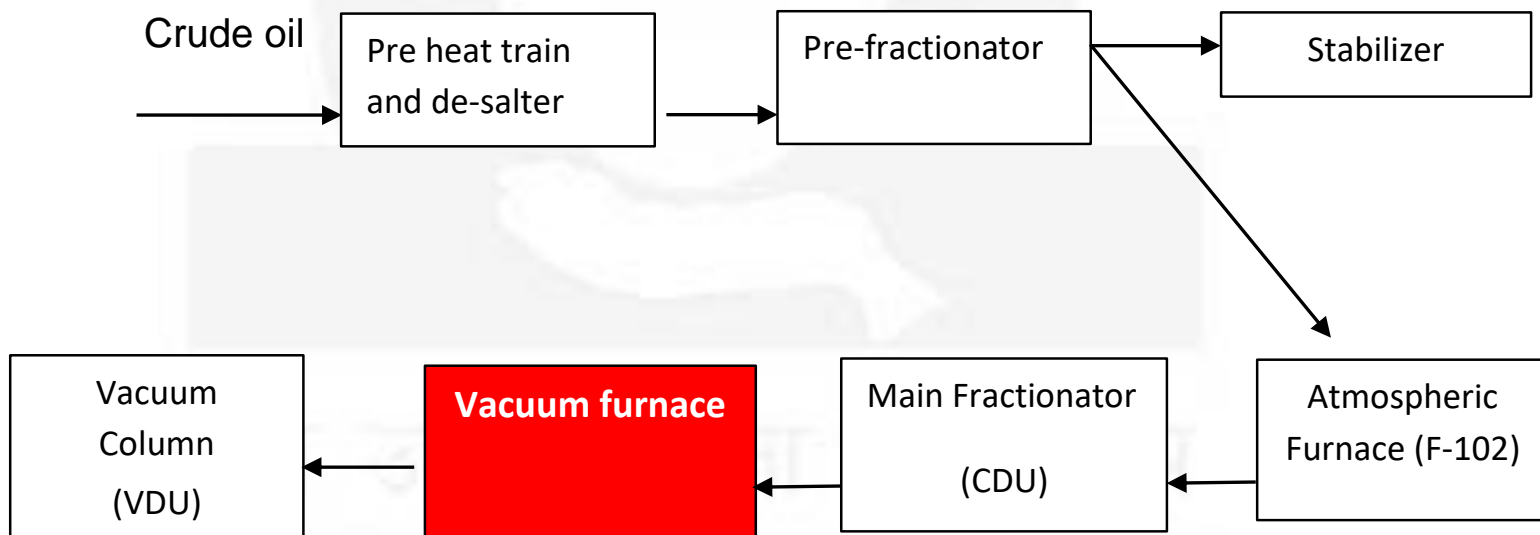
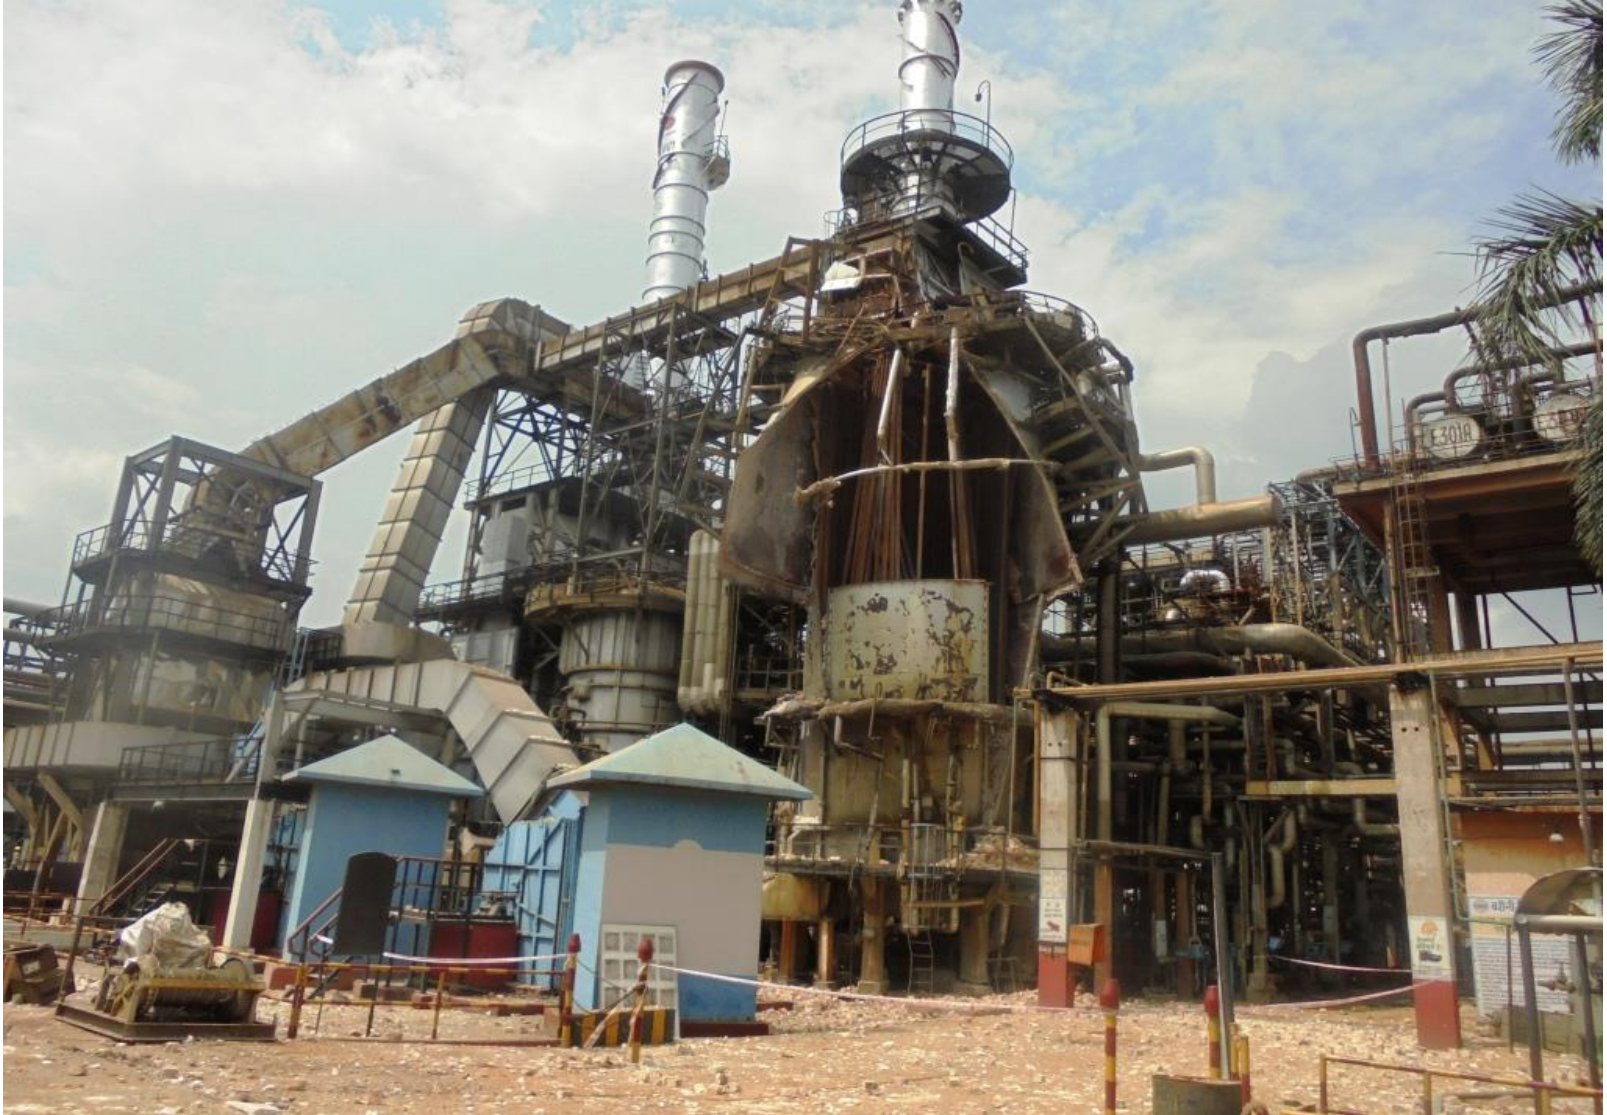
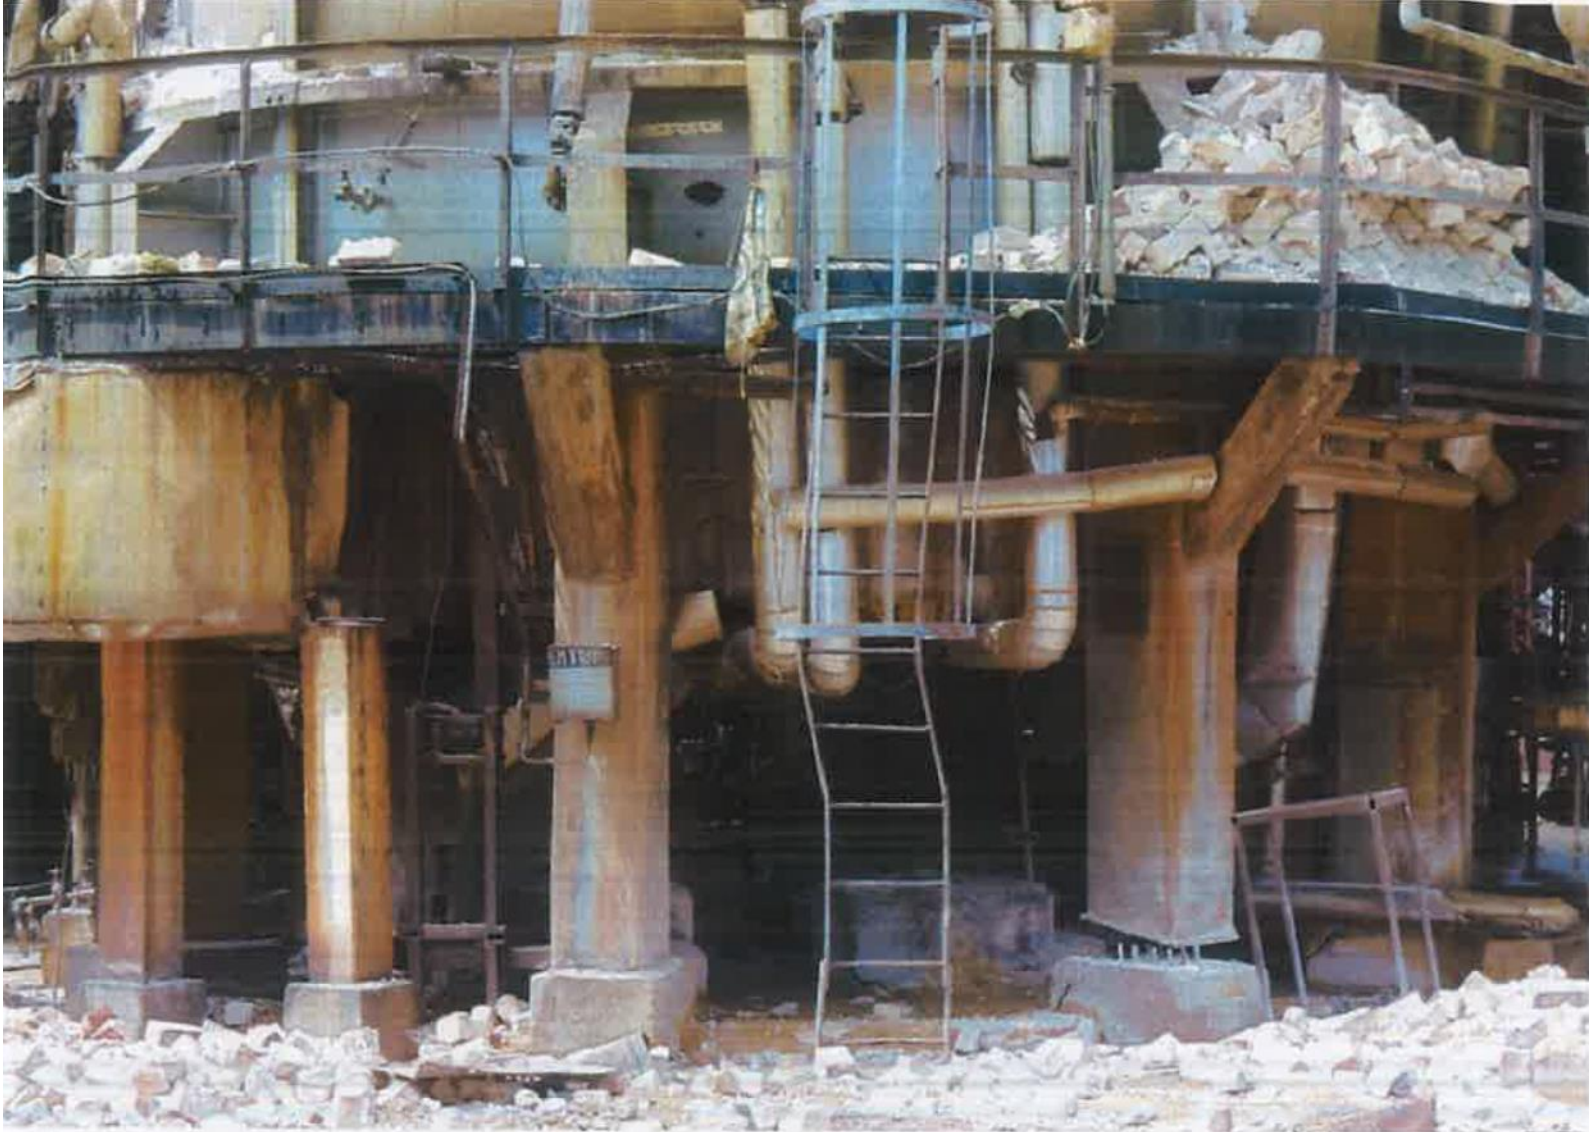
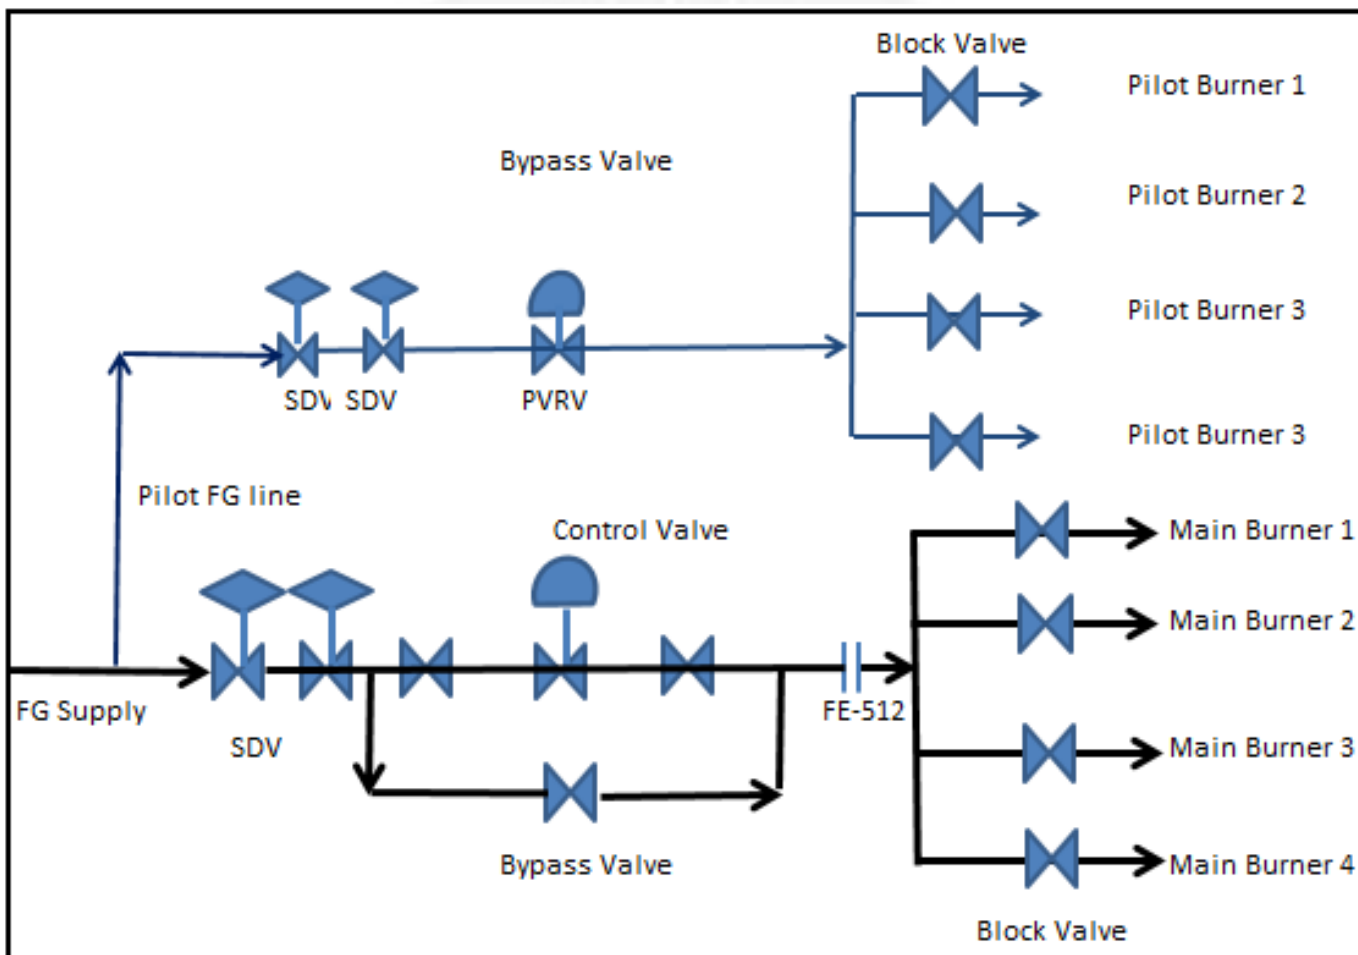
# Furnace Blast

An incident of an explosion inside the vacuum column furnace of Atmospheric Vacuum Unit during light up of the burner, causing damage to the furnace and injuries to the personnel.

- ✓ There was unobstructed flow & accumulation of Fuel Gas (FG) inside the furnace box for about 40 min prior to going for burner lit-up.
- ✓ No steam purging of furnace was done just before burner lit-up. It was done about 1.5 hr. earlier.
- ✓ Flow indication of FG through burners for about 40 min (without burners being lit-up) was not noticed at DCS panel and no alarm was raised.
- ✓ Lighting of main burner was done without lit-up of Pilot burner against SOP guideline- Normalization of deviation

- ✓ **Adhere to SOP**
- ✓ **Regularly review and improve SOP**
- ✓ **Training need to be regularly identified**
- ✓ **Ensure Internal audit recommendations are implemented in time bound manner**
- ✓ **Implement Concept of checklist in startup and shutdown activities to ensure the correct sequence of operation and time required**
- ✓ **Practice written instructions and ensure acknowledgement of all concern**

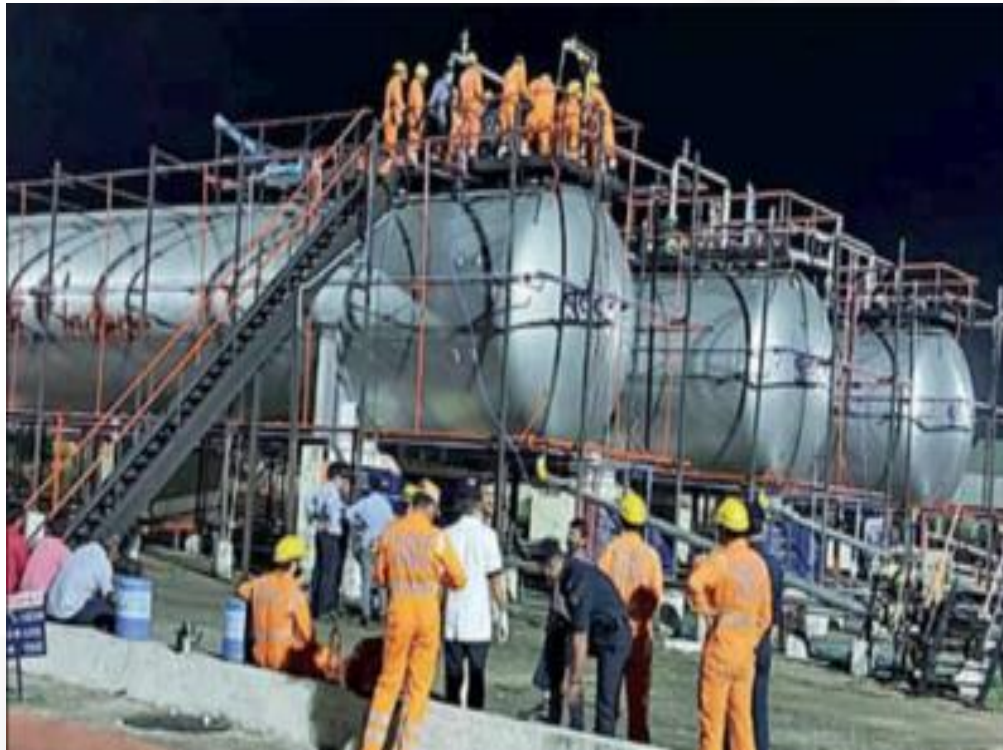
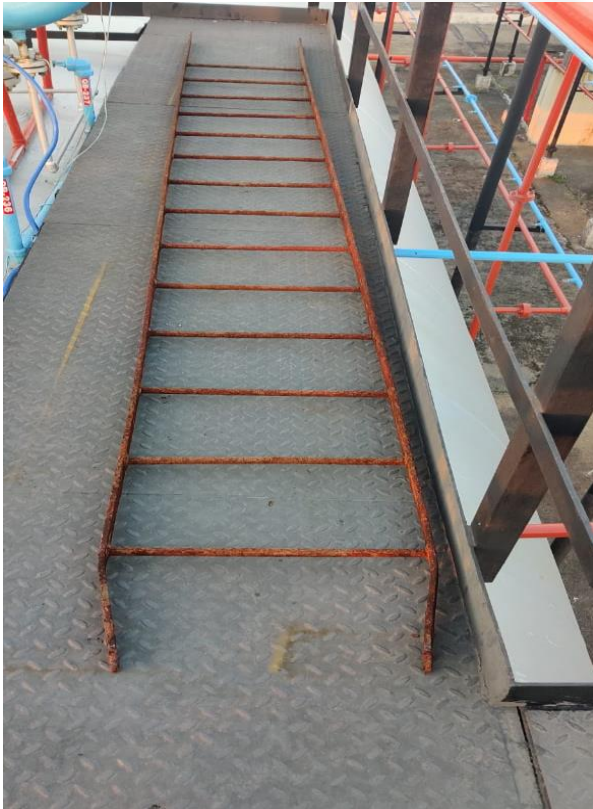
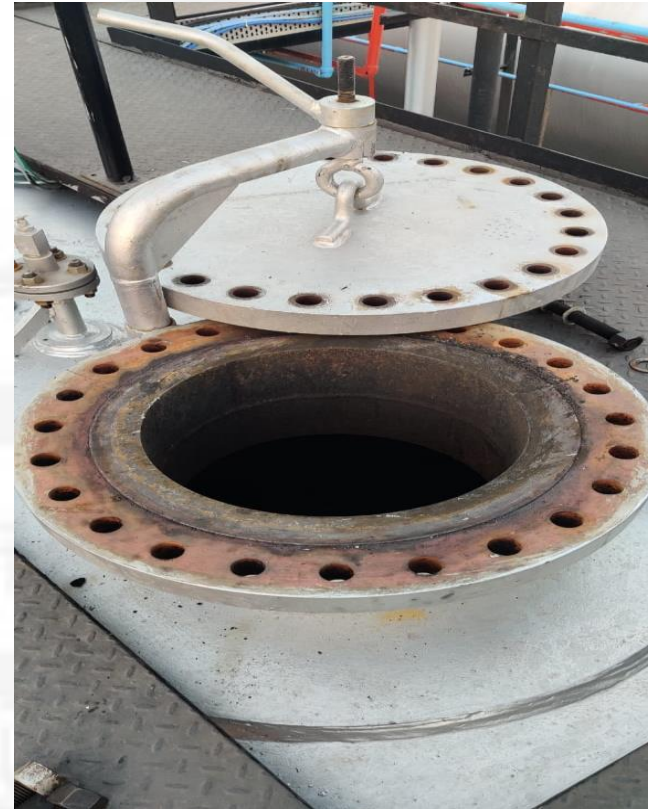
# LPG Bullet Mishap

Fatal incident took place during the degassing process of 150 MT capacity above-ground LPG storage bullet of a Bottling Plant

In order to speedup the process of degassing of bullet, water filling through top manhole was attempted which eventually led to the accident

- ✓ Non Compliance of Standing Operating Procedures (SOP)
- ✓ Poor understanding of procedure
- ✓ Lack of supervision by plant personnel and Contractor
- ✓ Non-compliance of Work permit system
- ✓ Emergency handling response
- ✓ Lack of exposure/ proper training to Officers
- ✓ Recording and review of log books/ dip book

- ✓ **Comply SOPs**
- ✓ **Review SOP and Share horizontally**
- ✓ **Improve Supervision of work**
- ✓ **Clearly define Third party responsibility in Contract**
- ✓ **Train and test your Contractor**
- ✓ **Ensure adequacy of Equipment for rescue operation**

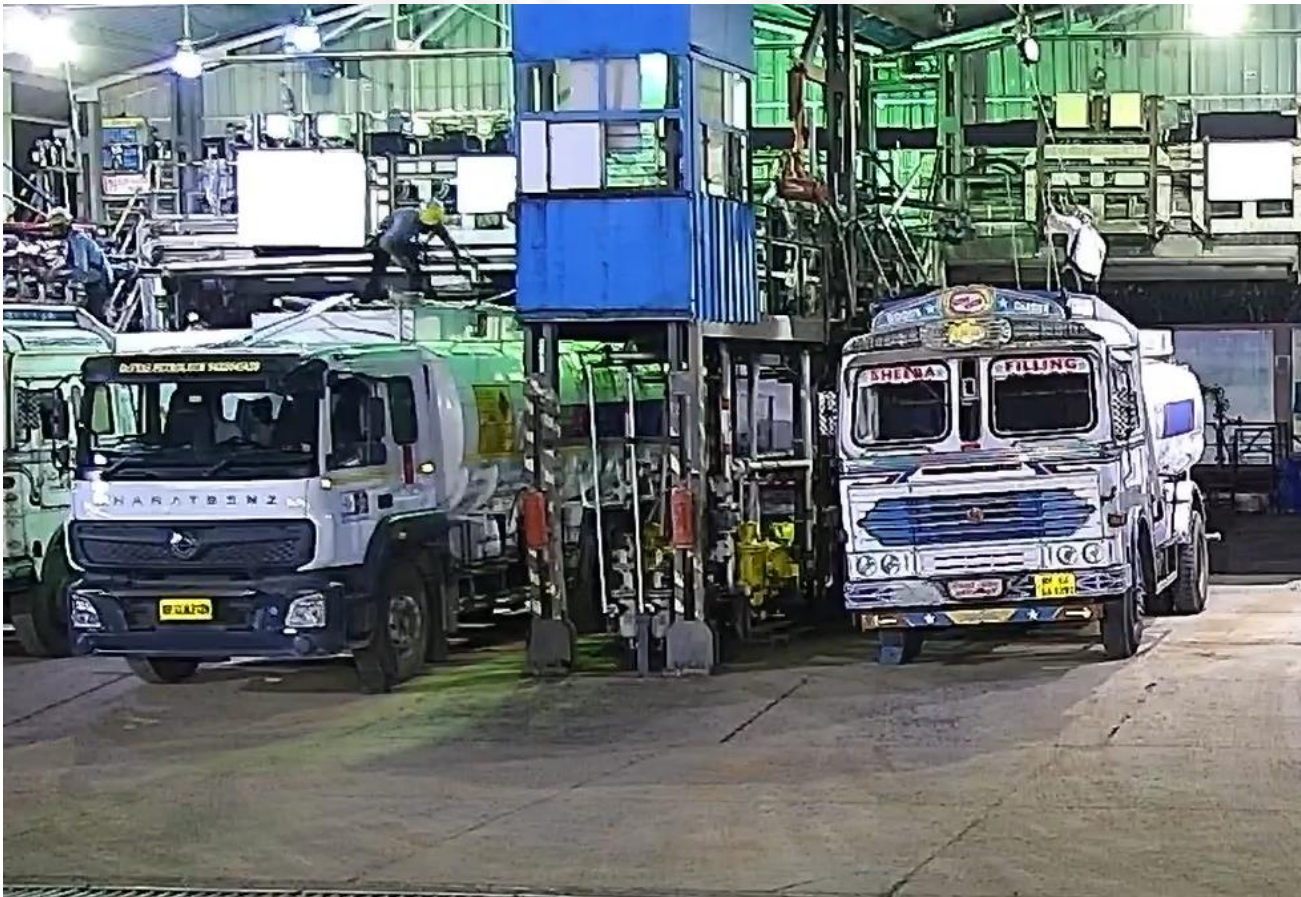
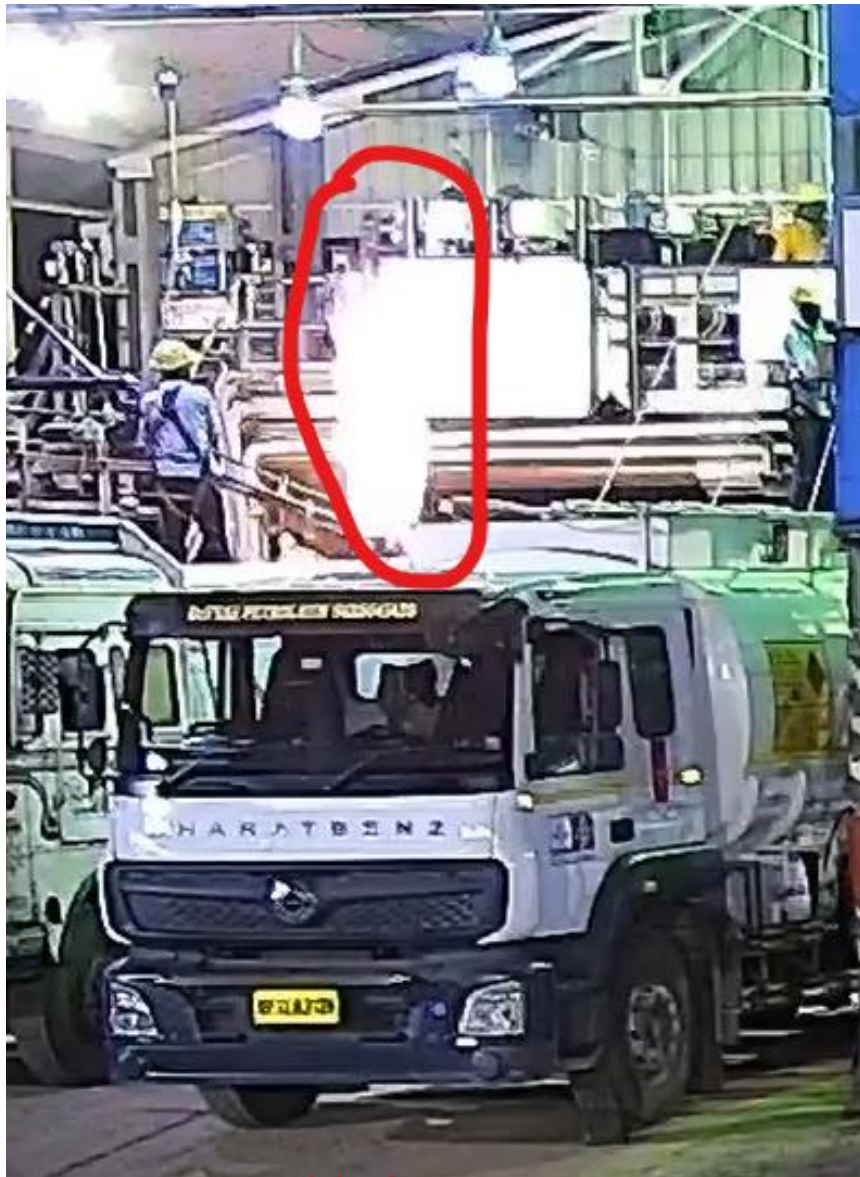
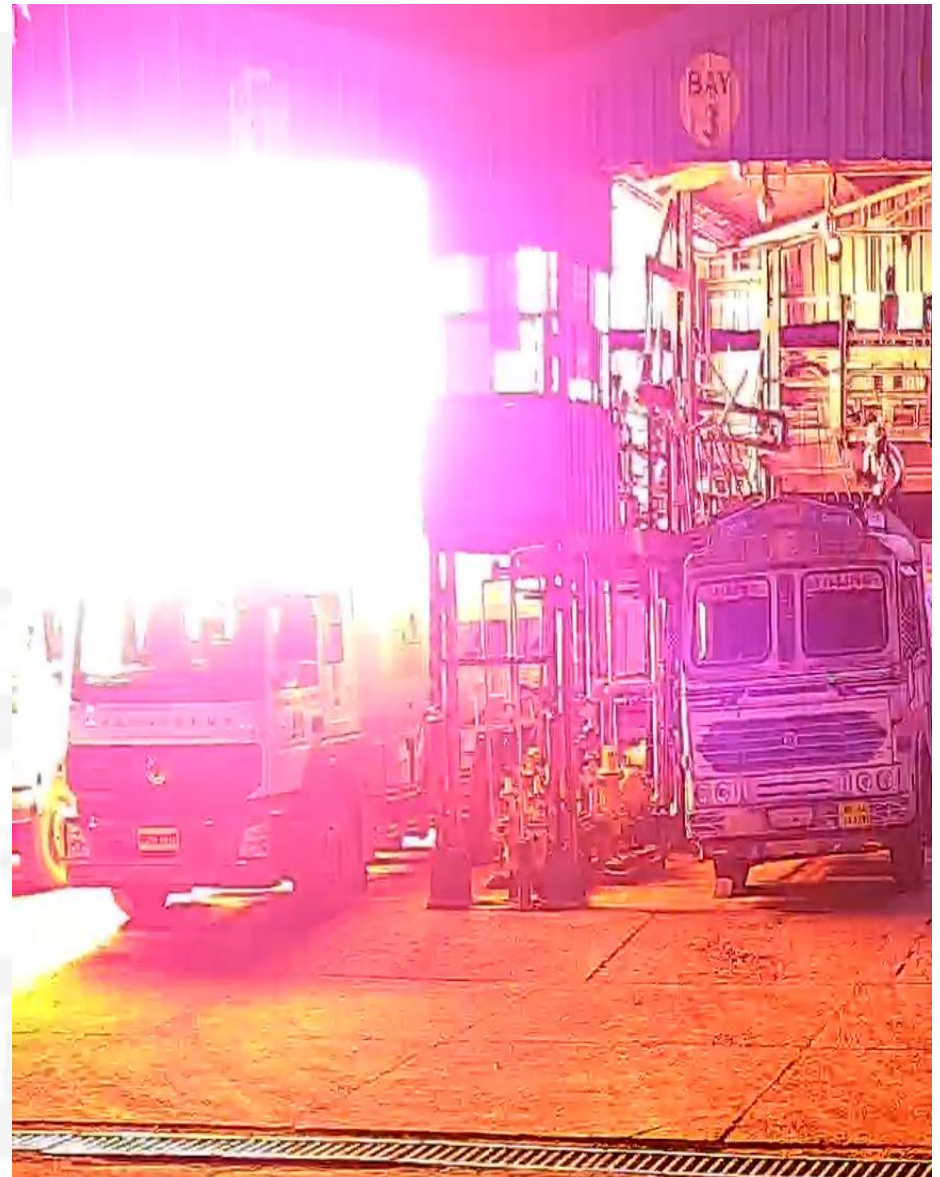
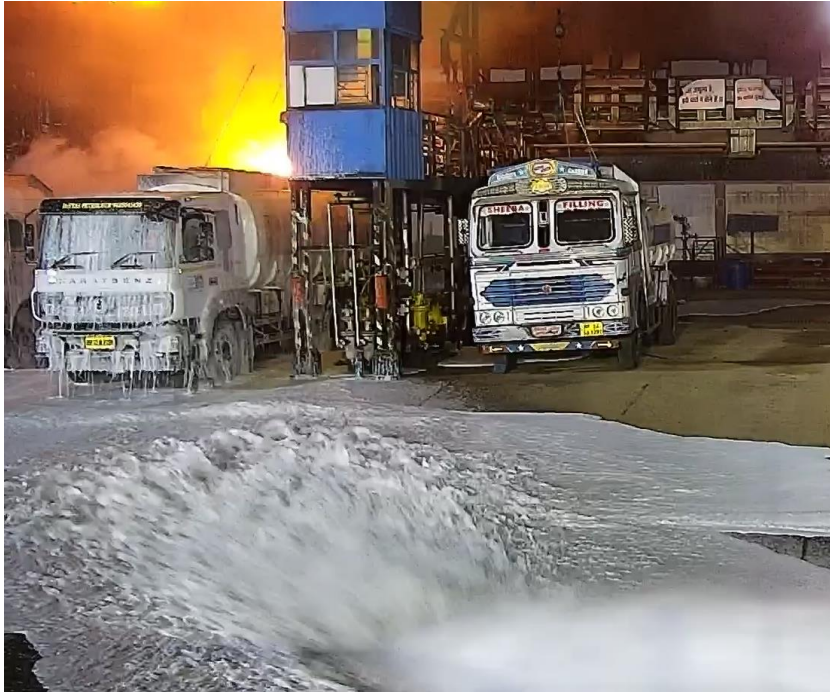
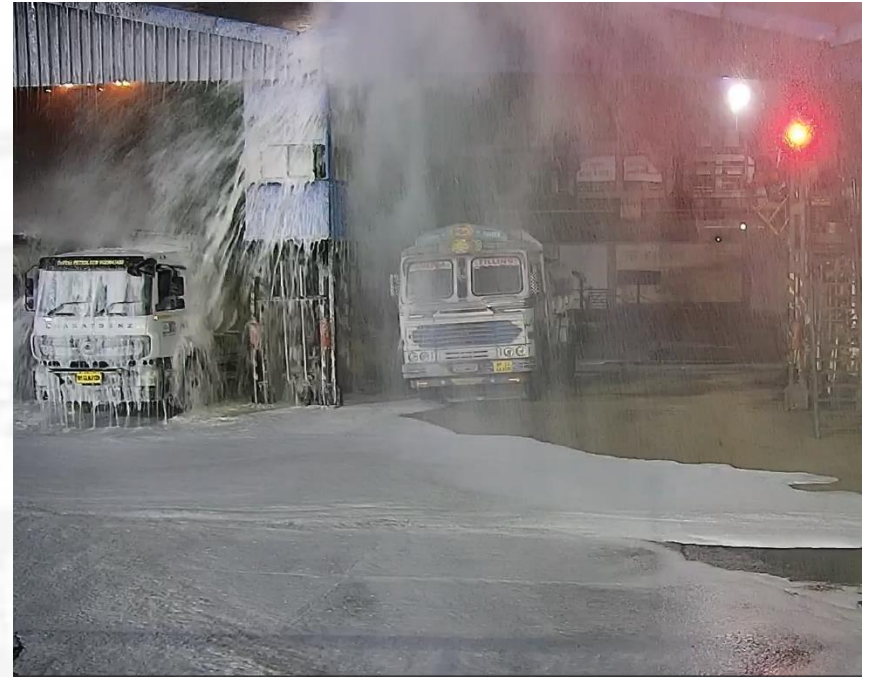
# VCE AT TANK LORRY FILLING GANTRY

**Explosion followed by Flash Fire occurred which engulfed 3 tankers and resulted into fatal injuries**

- ✓ **Earthing failure**
- ✓ **Disregard of procedures /safety guidelines**
- ✓ **No check to ensure earthing correctness (Ineffective supervision)**
- ✓ **Deviation in operation in TAS( “connect earth” alarms” were ignored )**
- ✓ **Inappropriate protective clothing**
- ✓ **Evidence of training was missing**
- ✓ **Escape route was not available to TT crew at bay no. 1**
- ✓ **In case of excess fill, Unloading bay was not used, locally collected in drums**

- ✓ Ensure static electricity is dissipated during loading operation
- ✓ Ensure absence of MS vapors or liquid in case of switch loading
- ✓ Ensure no safety interlock is by passed during loading
- ✓ Strict adherence to the work procedures
- ✓ System for identification of unsafe acts and conditions and its reporting by the operating personnel shall be strengthened at the organization level
- ✓ Compliance of audit observations
- ✓ Train contract staff and workers
- ✓ Use of correct protective clothing
- ✓ Convert all top loading tank lorry filling gantries to bottom loading with vapour recovery system in a time bound manner
