PNGRB Knowledge Sharing Workshop

Safety during Shutdown & Startup

By : Mr. B K Panda, Head of Safety, Paradip Refinery

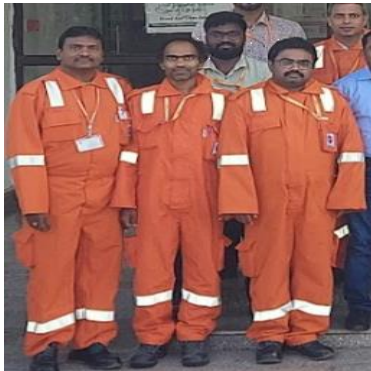
TIER-I
Process Safety Assurance

Tier 1 - Process Safety Assurance Team (Officers drawn from TS, HSE, Production & QC Laboratory)

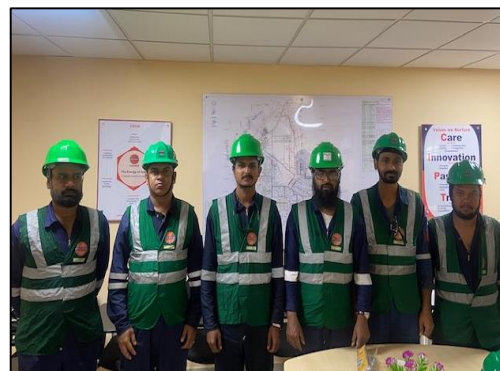
TIER-III
Electrical Safety Surveillance Team

Tier 3 - Electrical Safety Surveillance Team

1. Check for SMS (Sanitization, Masking & Social Distancing) for COVID-
2. Electrical equipment checking at site and sticker affixing
3. Check power connection from Electrical Substation to end use
4. Check for RCCB installation, Earthing/Bonding etc.
5. Random testing of RCCB/ELCB.
6. Overall Electrical Safety Compliance
7. Check for LOTO Compliance

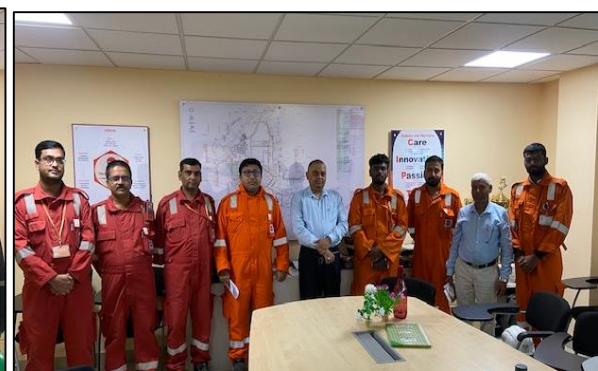
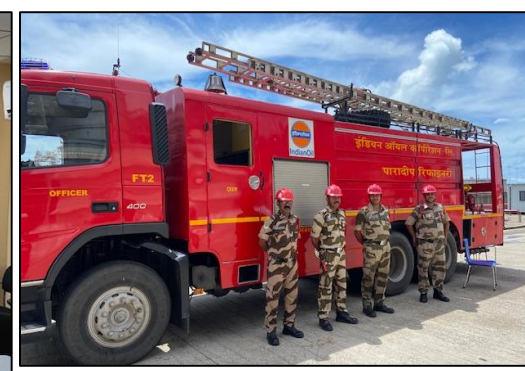
TIER-IV
Temporary F&S Posts at 2 locations

Tier 4 - Emergency Handling Team : Establishment of Temporary Fire & Safety Posts at Two strategic locations for quick response during any emergency & monitor safety compliance with on the spot correction at site.

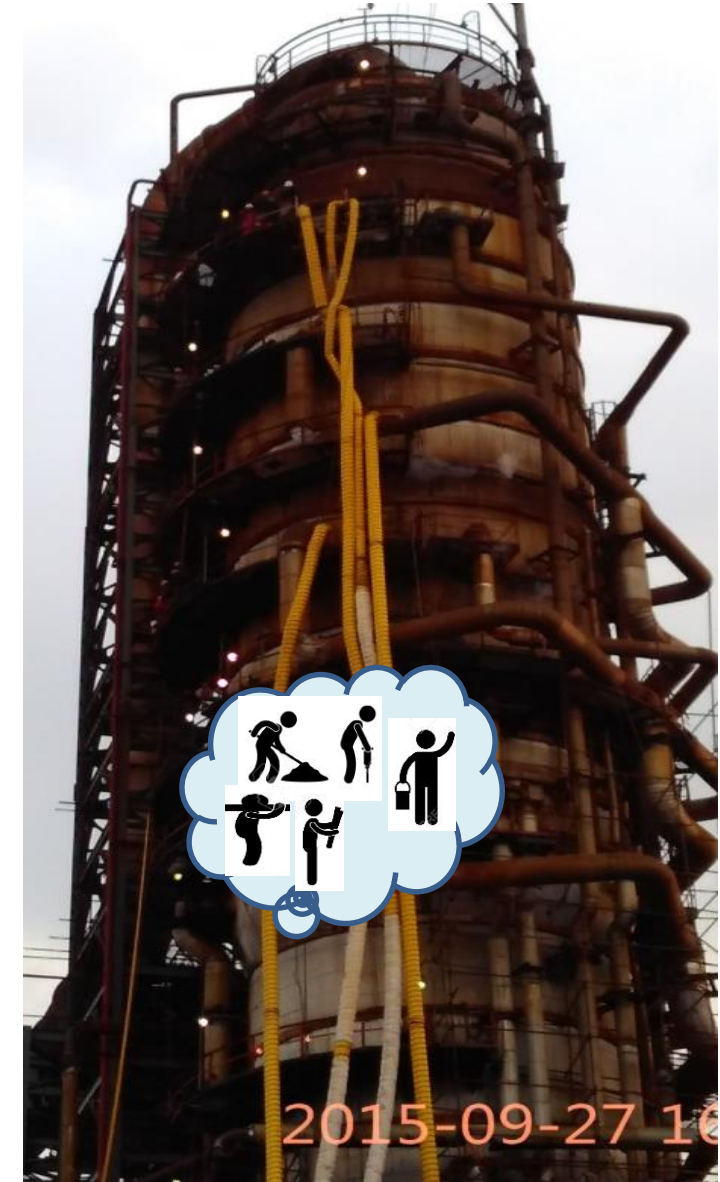
Ventilation inside Confined Spaces

- Blowers & fans provide mechanical dilution ventilation.
- Be sure the blower is appropriately sized, explosion-proof, and its intake is placed far enough away from any source of contamination - like an exhaust pipe on a vehicle!
- A space under positive pressure will eventually expel the contaminant through an opening but the time it takes is the real question.
- Localized exhaust ventilation is better suited to capture fumes (welding), dust and chemical contaminants.

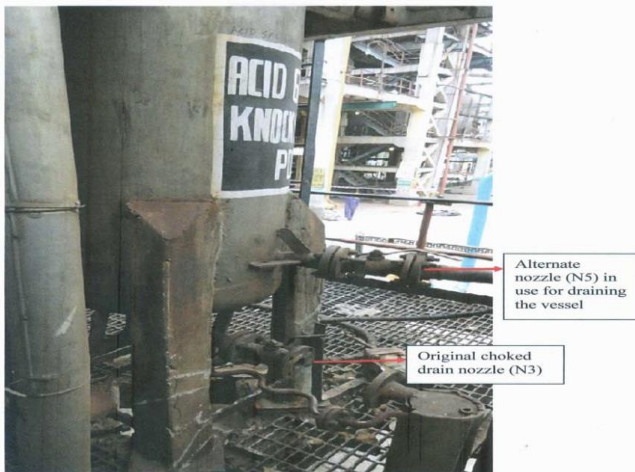
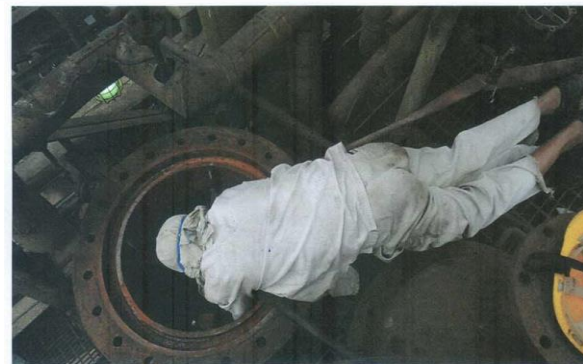
Person might have carried out the hydro jetting operation in the posture as depicted above.
(Photograph taken only for reconstructing the event)

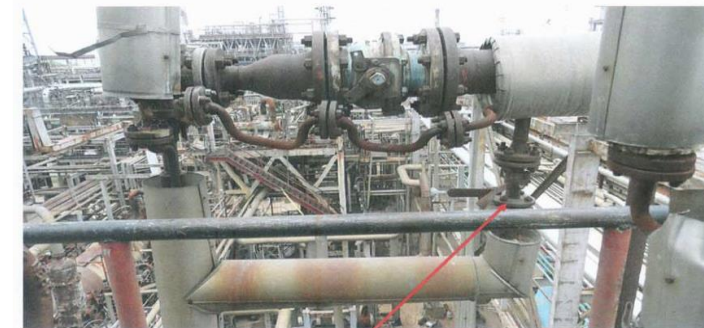
(PSV discharge line of the vessel to Flare)
Bypass valve not blinded prior to opening the vessel

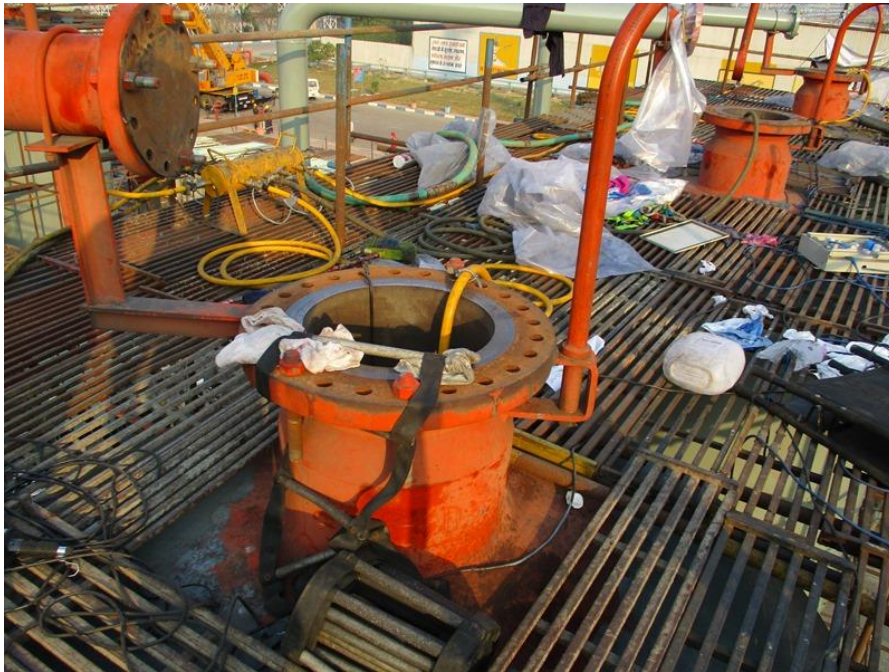
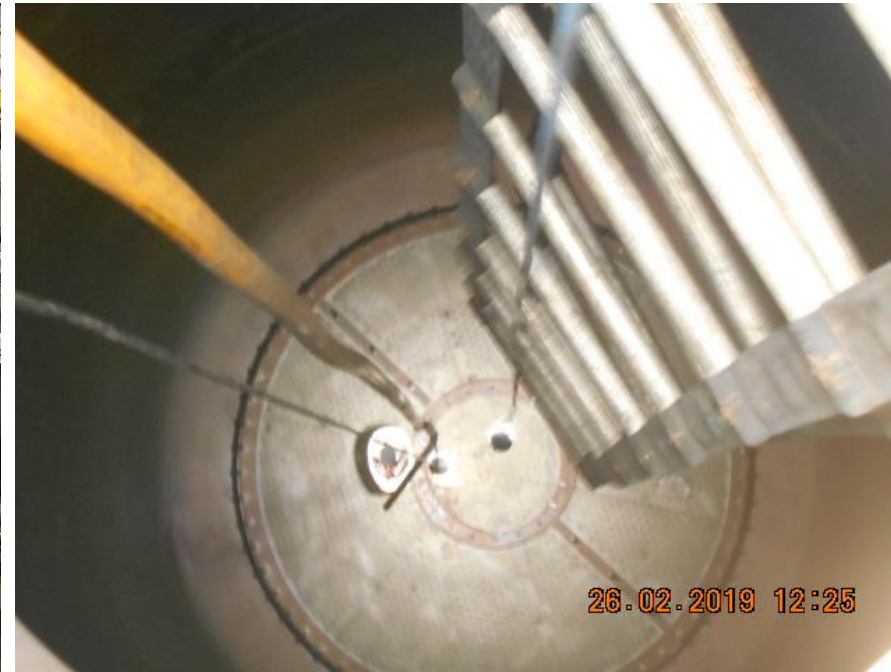
After performing DP test, Inspection engineer started climbing up using safety harness with life line. Material was tied with his life line

The immediate cause of death of the deceased Shri Shukla was the head injury caused by fall from height and detachment of the helmet from his head.

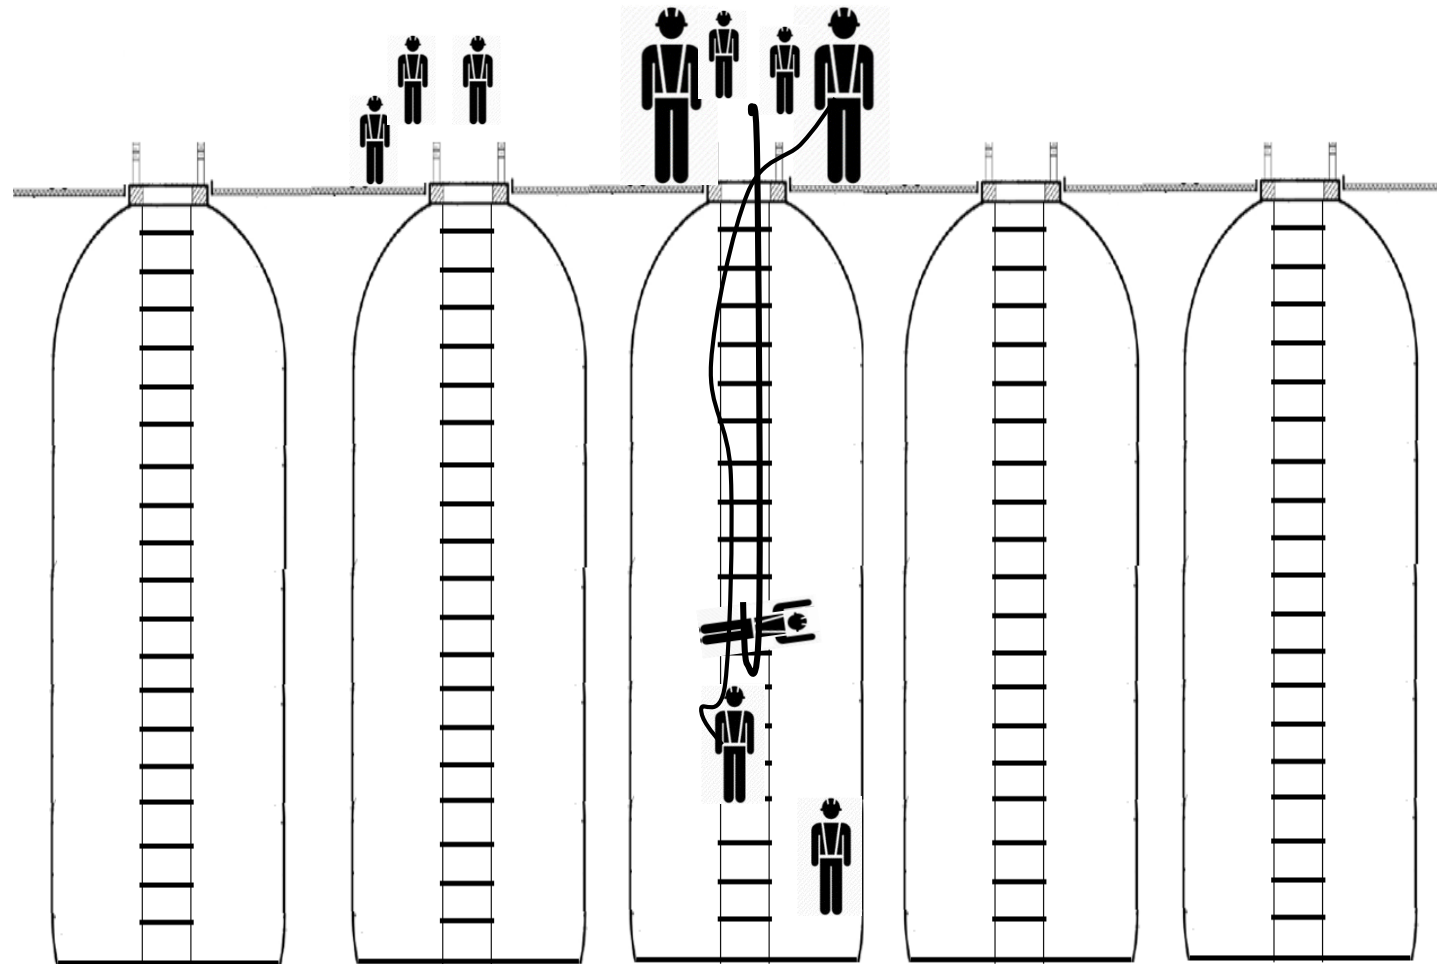
The person was taken out by securing life line to his safety harness.

The simultaneous use of the rope ladder while climbing up might have led to abnormal swings of the rope ladder and resultant imbalance and loss of grip on the ladder by the deceased causing his fall.

- **Work Permit Issuer & Receiver must ensure to depute two stand by person outside confined space entry point and shall explain safety conditions to enter inside confined space & associated hazards to the stand by persons, special hazards for entry/ exit.**
- **Proper location and job specific JSA should be carried out for all the confined space entry jobs by multidisciplinary team.**
- **To avoid intra/inter departmental communication gap, Job specific permits should be taken for all the individual jobs carried out inside confined space.**
- **Job safety analysis (JSA) submitted by any contractor or agency shall be used as reference only. JSA for any critical activity to be done by IOCL multidisciplinary group.**
- **Minimum test parameters shall be freezed for medical examination to work inside confined space and to work at height.**

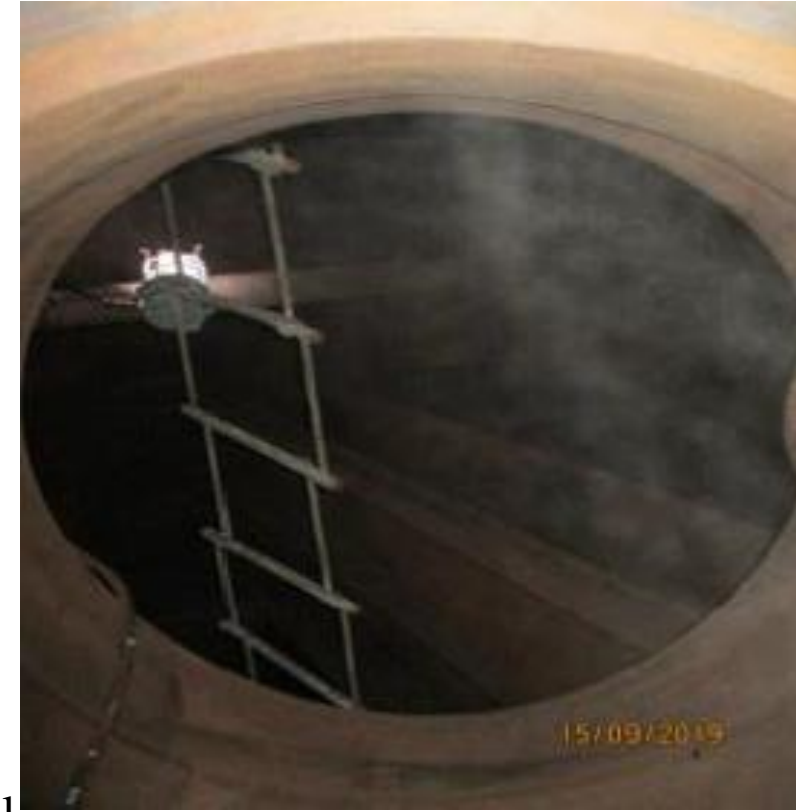
Near Miss Incident in Confined Space jobs

Incident: Confined space entry job was observed carried out in one vessel. All workers involved in men entry job didn't have specialized confined space entry training card. No fall protection safety arrangements provided at site like full body harness, fall arrester & life line. Column tray removed and kept at platform, which is obstructing free movement at platform No separate register/booklet maintained for In/Out entry record. Approved JSA copy not found with permit.

1. Lack of supervision by agency supervisor.
2. Non compliance of confined space entry permit.
3. Non use of fall protection devices.

1. The job shall all be carried out using the fall protection devices to prevent from free fall and injuries.
2. Workers shall undergo special training and get them validated for working in confined space.
3. Entry/exit manhole of the confined space shall be kept free from any obstruction for easy movement as well as any rescue activity if required.
4. Each entry and exit time shall be recorded in confined space entry register.

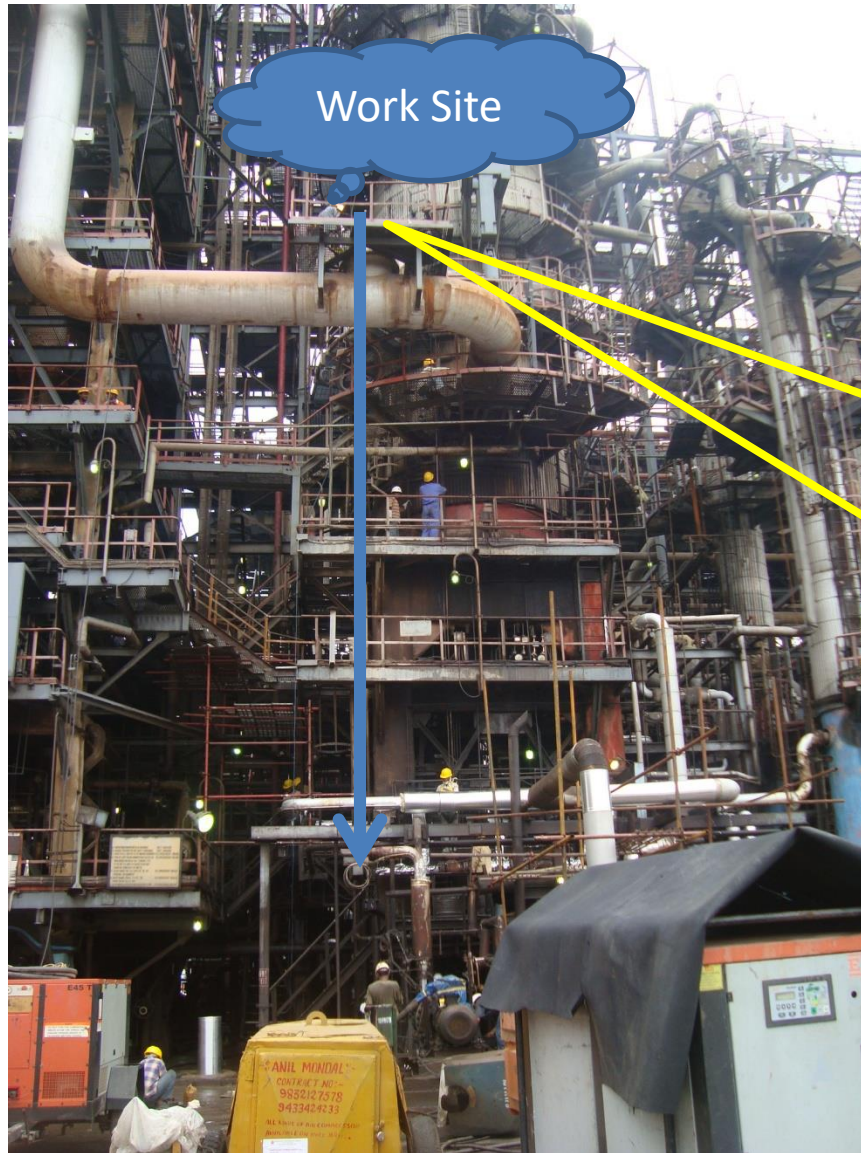
INCIDENT OF FALL OF OBJECTS FROM UPPER PLATFORM DURING S/D

Narrow escape due to fall of nut bolts from height

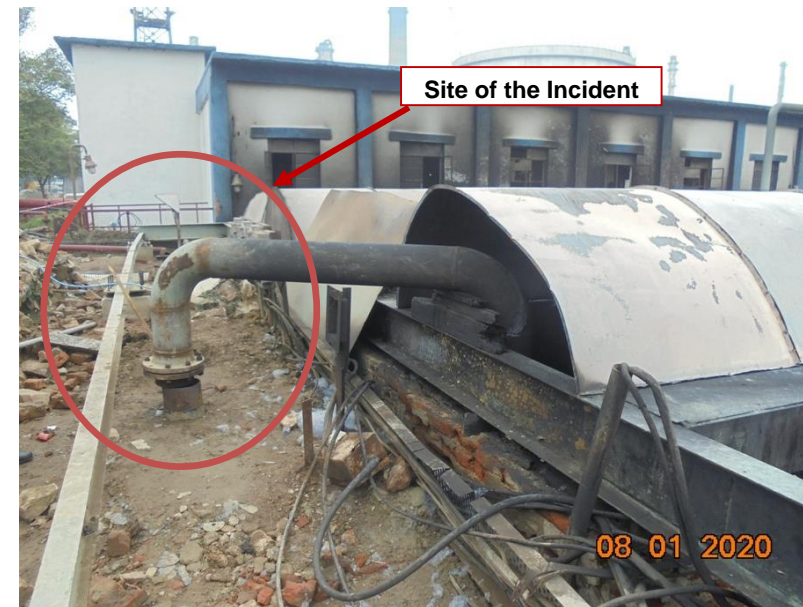
- VOC system was installed on Industrial Sewer (IS) sump about 2 months back. During erection of VOC system, a beam was installed at wall of the sump which was fouling with the existing spent caustic line, was removed by cold cutting to install the beam on the sump wall.
- For erection of pre-fabricated spool piece, the left over elbow of old Spent caustic header was removed by gas cutting at around 11:00 Hrs. on 07.01.2020.
- The side cover of VOC system over IS sump was removed for placing of the pre-fabricated spool.
- The fit up job between pre-fabricated spool (8") of about 3 meter length and existing spent caustic line was in progress.
- For alignment of the spool, cleat tack welding was initiated, the spark generated and resulted into fire at 11:47 hrs.

**Another fire incident was reported at around 16:43 Hrs at the same location which fire fighting team extinguished instantly. The reason of second fire incident was suspected to be spark generation in burnt cables of IS Oil Skimming pump, which was operated in the meantime*

- Work permit should be taken for specific jobs and it must have clear and complete description of the work.
- Job safety Analysis shall be necessarily conducted for all critical hot jobs.
- Tool Box talk shall be given for the specific job.
- Mandatory Gas Testing before hot job to be done.
- Continuous monitoring of HC Vapors / toxic gases shall be ensured while carrying out hot jobs in plants under operation.

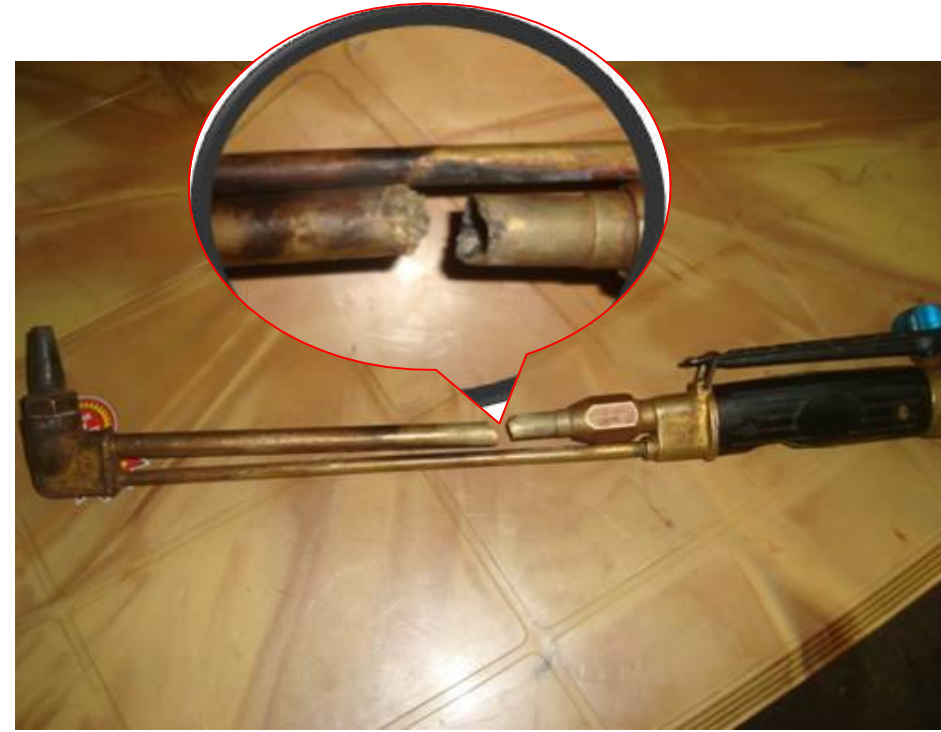
Flashback causing rupturing of mixture chamber. Had flashback arrestor not been used, it would have led to explosion in cylinder.

Never light your torch with a mixture of fuel and oxygen. After purging the lines, light the torch with only the fuel gas valve open. Always ensure use of Flash Back Arrestor at Torch end & cylinder end.

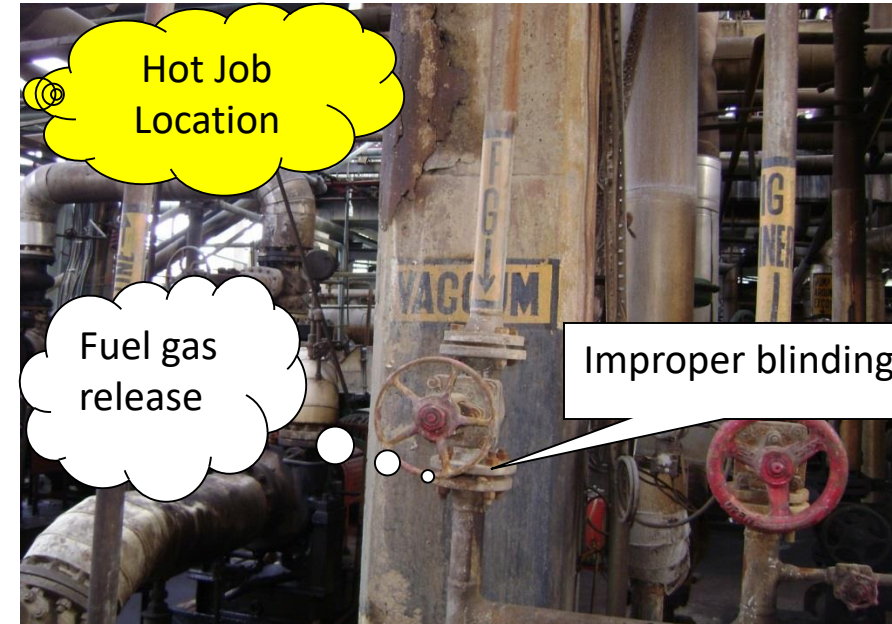
IMPROPER BLINDING

Incident: Improper blinding led to fire from hot job nearby. Three cases of similar nature took place.

Root Cause : Fuel gas line was isolated by block valve and blinded by a tail blind still fuel gas was slightly passing.

LESSON LEARNT: Proper blinding with proper gasket. Do not rely entirely on block valves, also ensure for positive isolation by blinds.

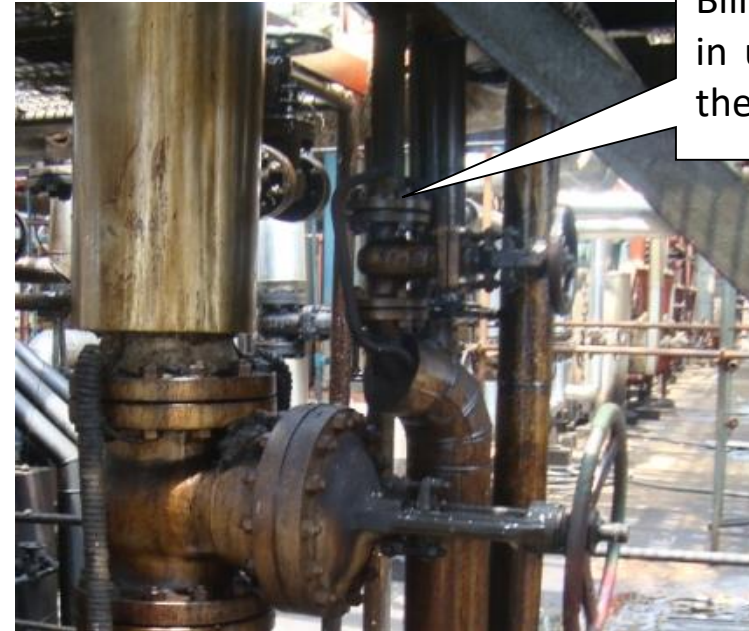
IMPROPER BLINDING

Incident : Fuel Gas leak from flange while deblinding during the startup of on of the unit.

Blinding done in the upstream of valve.

Blinding done in upstream of the valve.

Lesson Learnt: Blinding to be done in the downstream of valve under proper supervision of Production/Mech Maint.

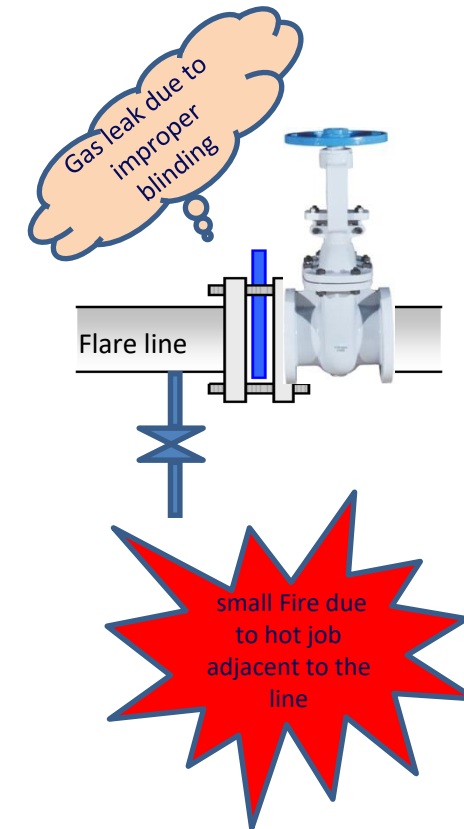
IMPROPER BLINDING

Blinds to be properly tightened and gas test done before allowing hot work in the vicinity.

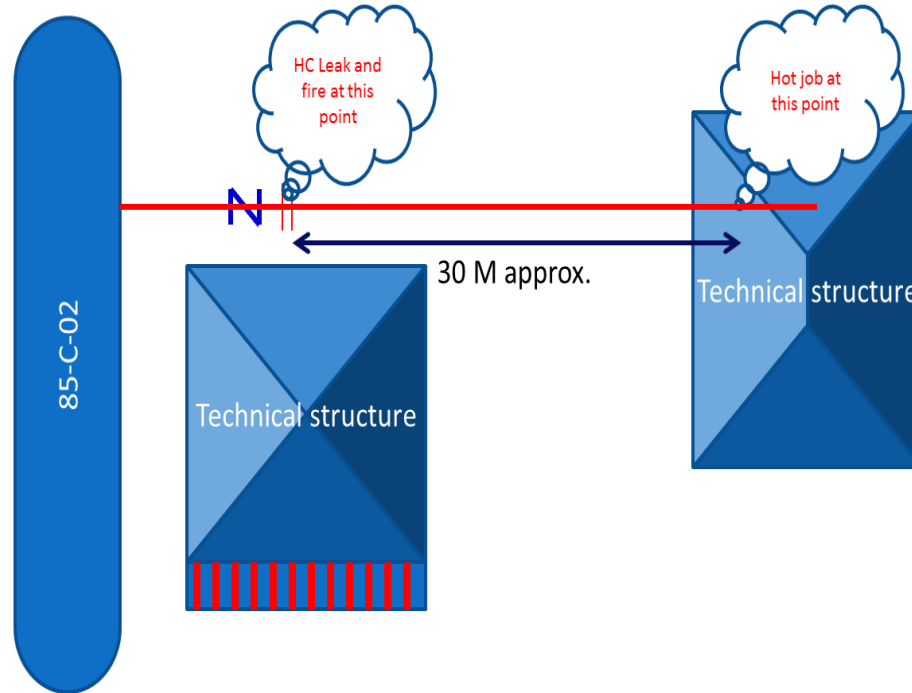
IMPROPER BLINDING

Incident: Fire at blinded flange in off-gas line connected to a process column at an height of approx 15 m near PSV technical structure.

- Improper blinding
- stoppage of steaming

Proper blinding to be ensured before hot job.

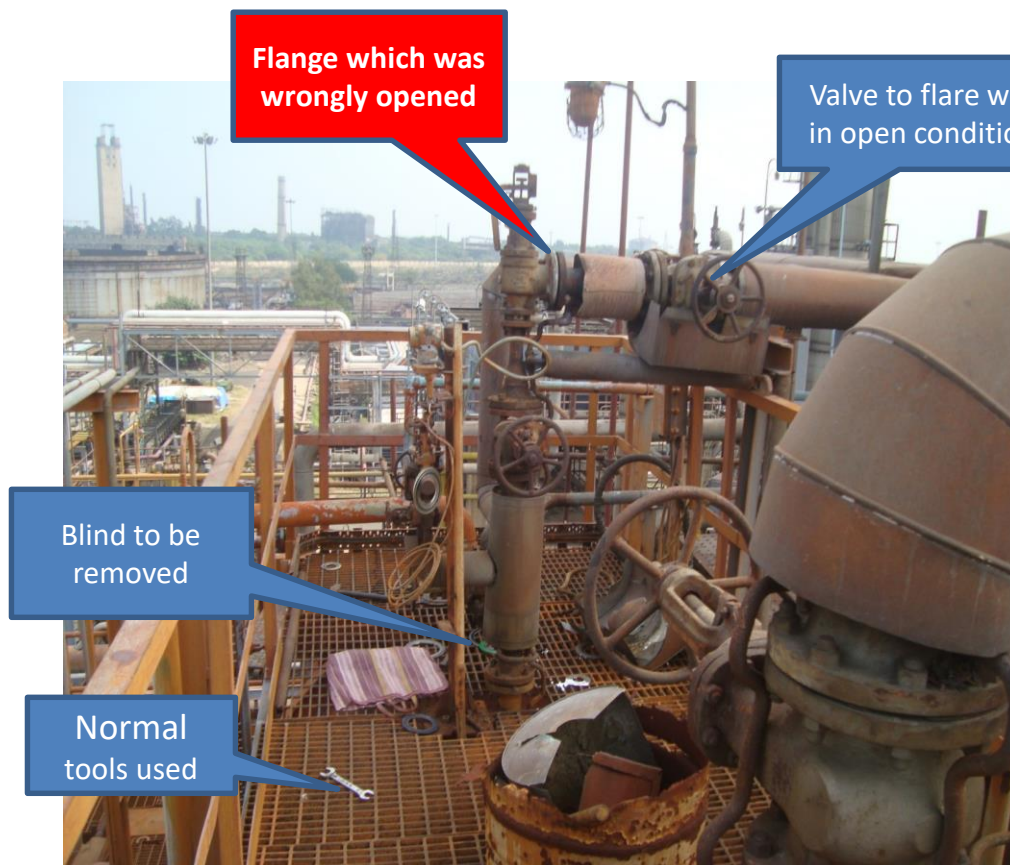
IMPROPER DE-BLINDING

Incident: Wrong opening of PSV flange with flare valve in open condition resulting in flash fire.

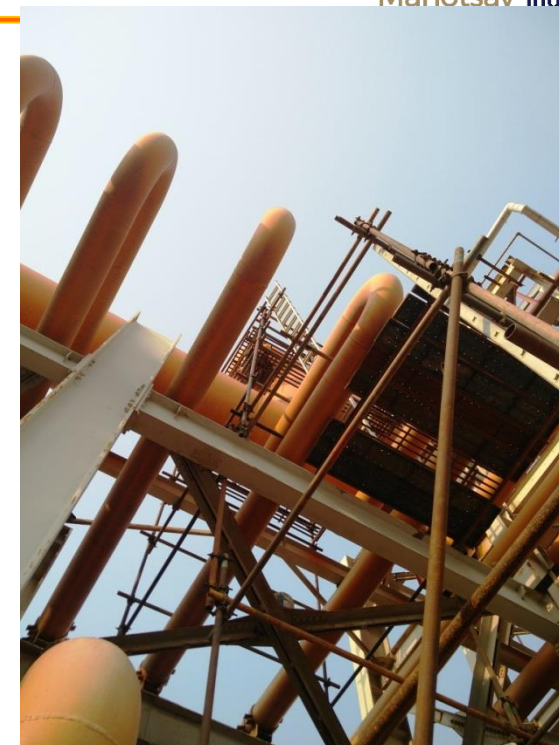
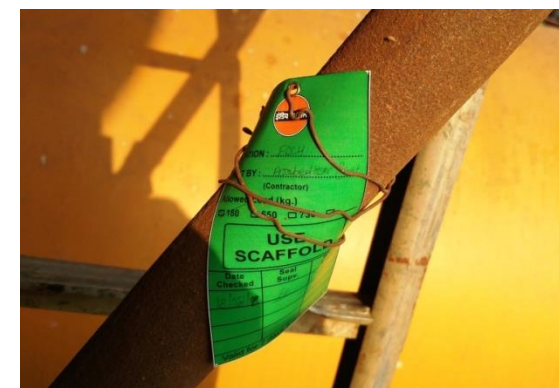
During shutdown activities, one of the technicians of M/s CORROSONIC was preparing for thickness survey of the inlet line of 23-AC-15. While climbing on to the scaffold platform at the elevated location about 37 mtr. at 23-AC-15, suddenly the technician got imbalanced as he placed his leg on one side of the scaffolding platform (Jaali) & the Jalli got lifted & tilted to one side as it was not fixed properly.

The platform (Jaali) was tied with the pipe in one side only and the other side was not tied with the scaffolding pipes. However, a green tag was found fixed on the scaffold pipe.

Improper inspection / checking & tagging of the scaffolding.
Non compliance of the scaffold safety procedure.

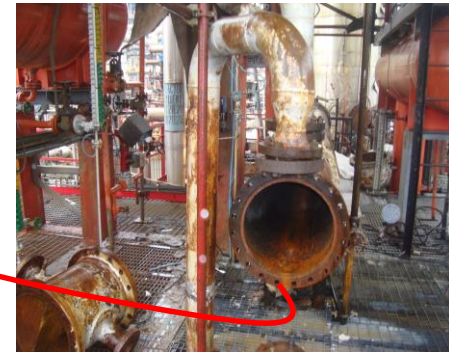
Fire Due To Hose Connected to Naphtha Vessel near Hot Work

Incident: Contract worker connected hose with LPD of vessel considering vessel having water. Naphtha from vessel spread in the area and caught fire due to hot job for grating.

Always keep LPD and HPD capped to avoid such connection. Instruct the agency to connect any utility point in presence of production only

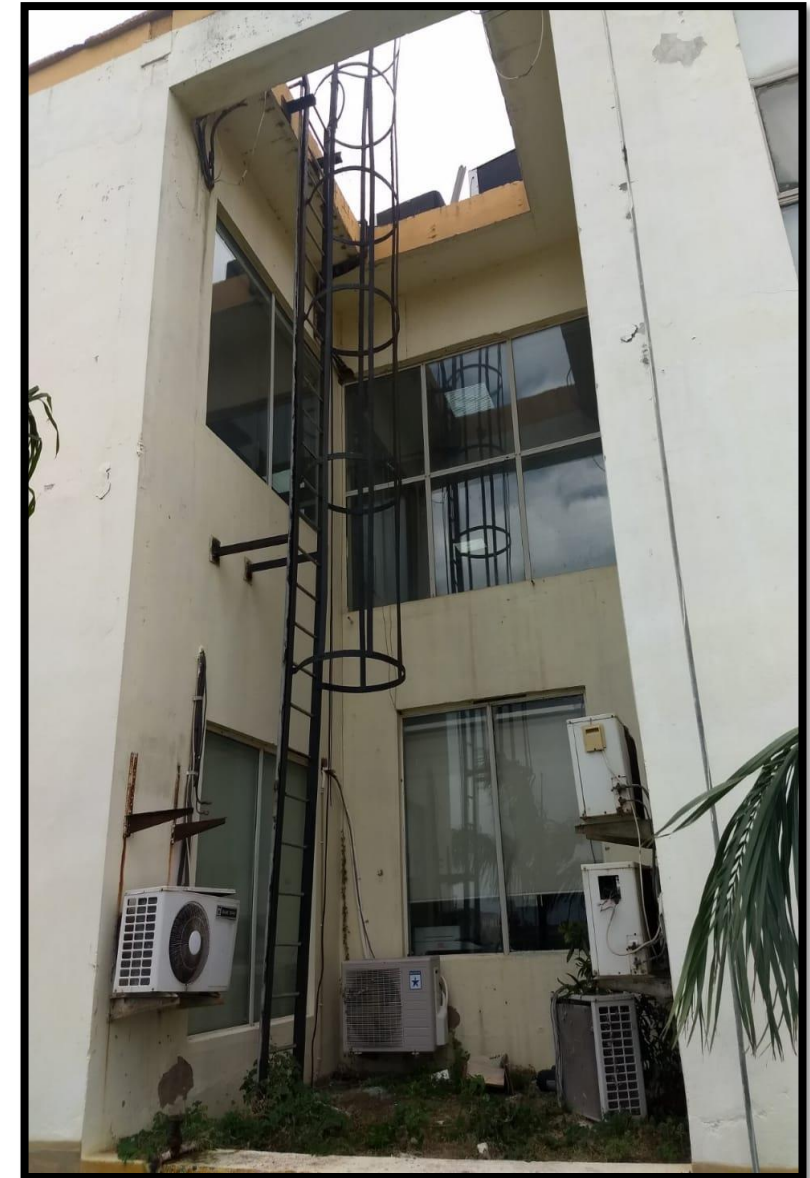
Fall From height from a caged Ladder

Shri Tushar Kanta Das, aged about 35 years, an Electrician working with M/s Unique Power Generation Pvt. Ltd., a contractor of M/s IOTUES fell down from the caged monkey ladder of the Technology Building of IOTUES in BOOT 3 area at around 10:25 hrs. on 11.06.2020.

While descending, his leg could have got entangled between the parapet wall and the top rung. The hand rail was placed on the side while ascending but not in the side of the descending. Therefore, while descending, there is the possibility that instead of three point contact, due to design deficiency of the ladder, two point contact might have occurred leading to slip an fall of Mr. Tushar.

- Additionally, wet condition due to rains could have made the rung slippery.
- Mr. Tushar was wearing helmet. However, its chain strap was turned towards back of the helmet (chin strap not used). Hence, the helmet might have got detached from his head before he hit the ground.

- Fouling of the two top rungs of caged monkey ladder with the parapet wall
- Non-adherence of safety practises by the IP– Fall Protection device not used -Double hooked full body safety harness
- Improper use of PPE- Safety Helmet used however its Chin Strap was not tied)

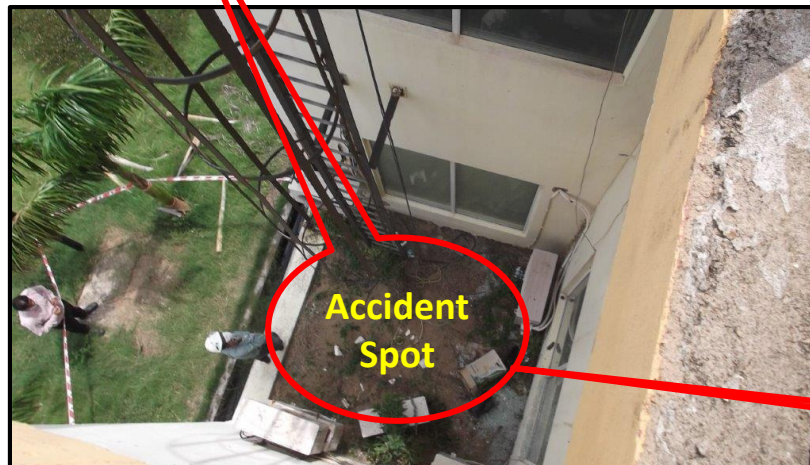
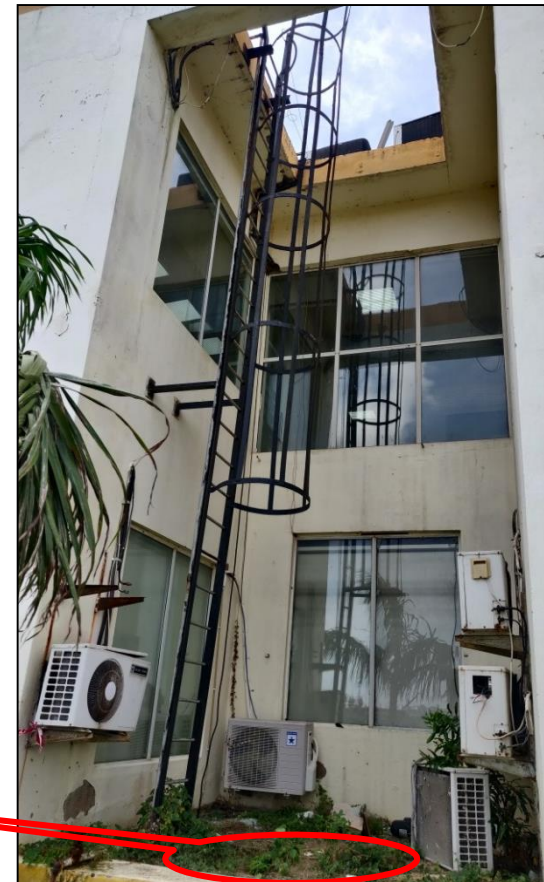
Fall From height from a caged Ladder

Cage Ladder Location at the Back side of the Technology building

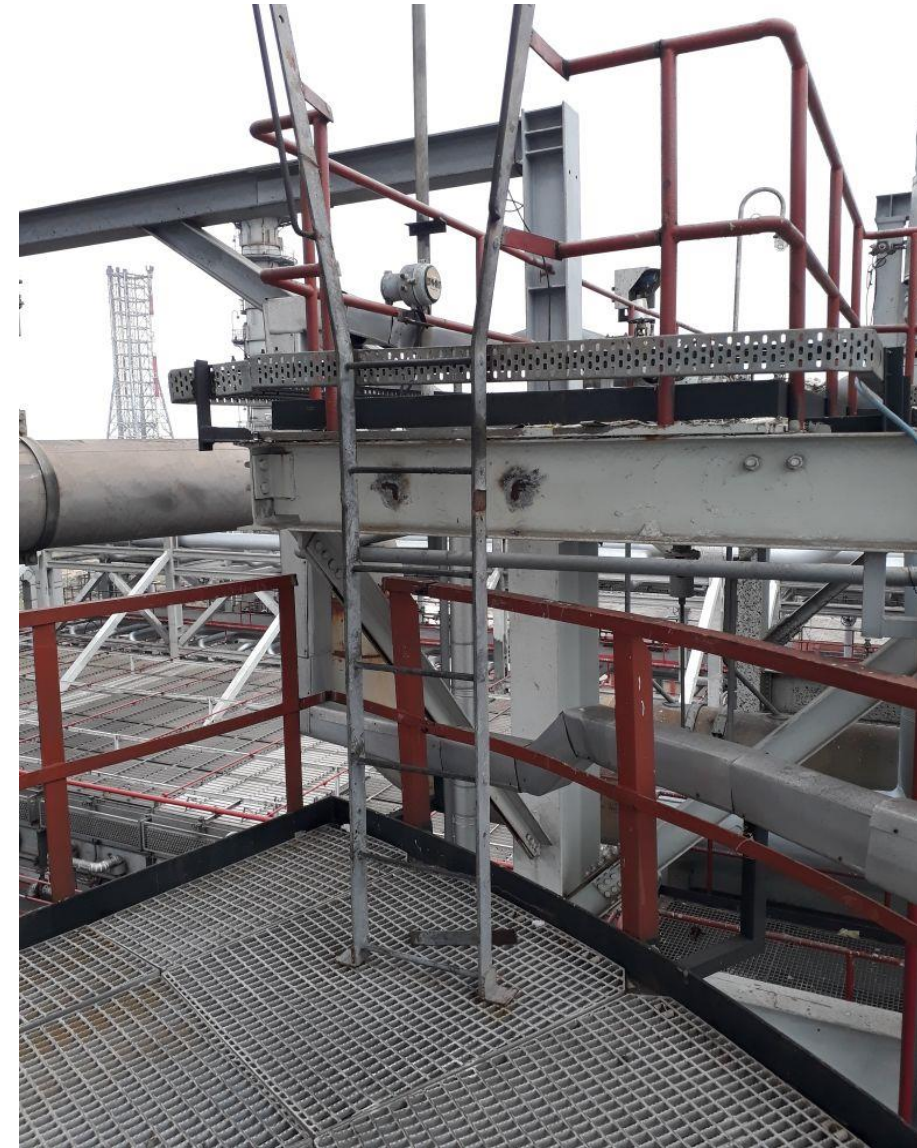
Improperly Secured Monkey Ladder

It was observed that the monkey ladder was found fixed with structure by tying with thin metallic wire and the wire snapped while the worker was descending.

Root cause of the incident: Equipment failure.

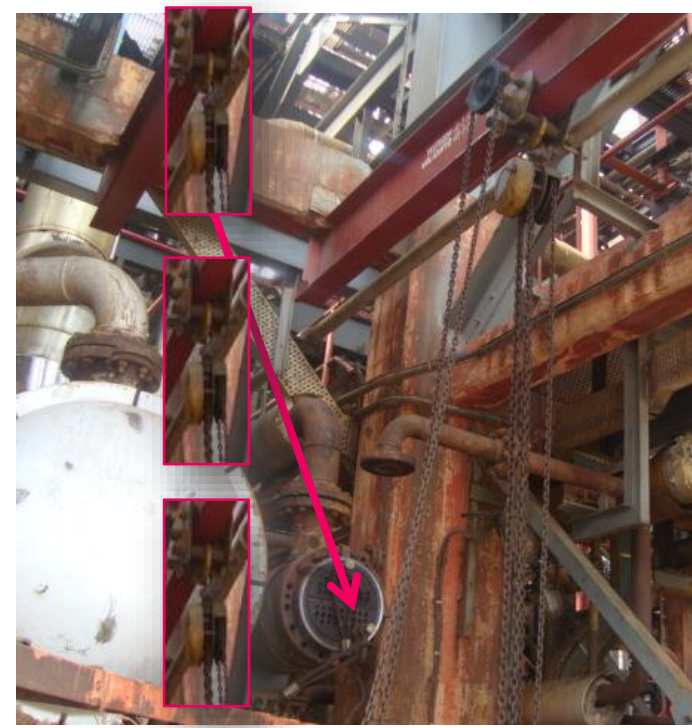
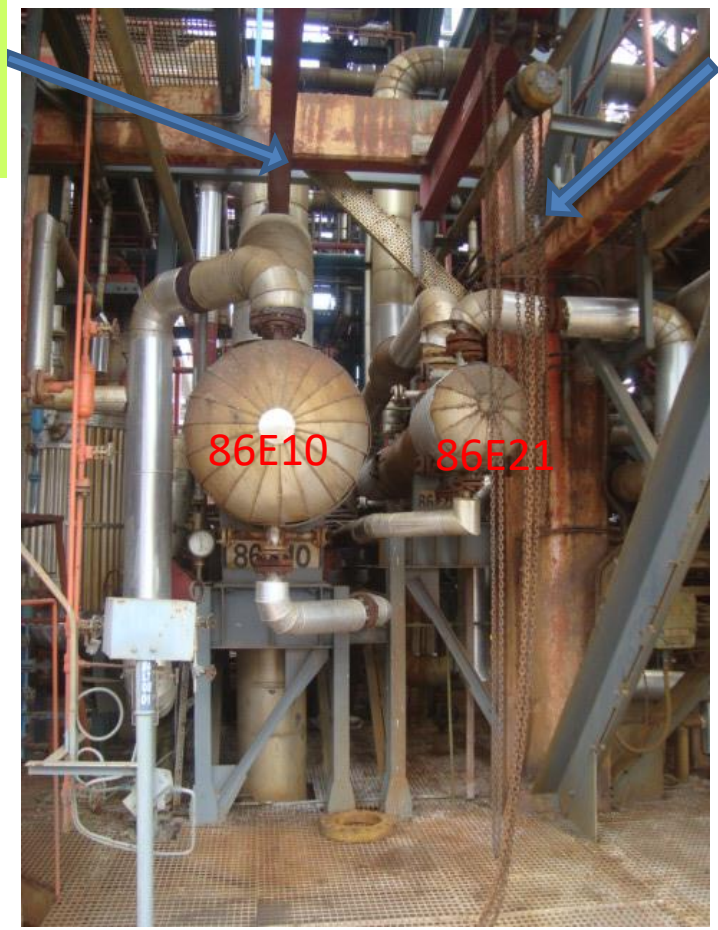
MONORAIL
L 1
SWL : 5T
Testing
Date :
10.05.2012

MONORAIL 2
SWL : 3 T
Testing Date :
10.05.2012

Monorail Trolley 1 was used for pulling out adjacent exchanger bundle (86 E21) at an angle to vertical direction

No erection plan and no JSA.

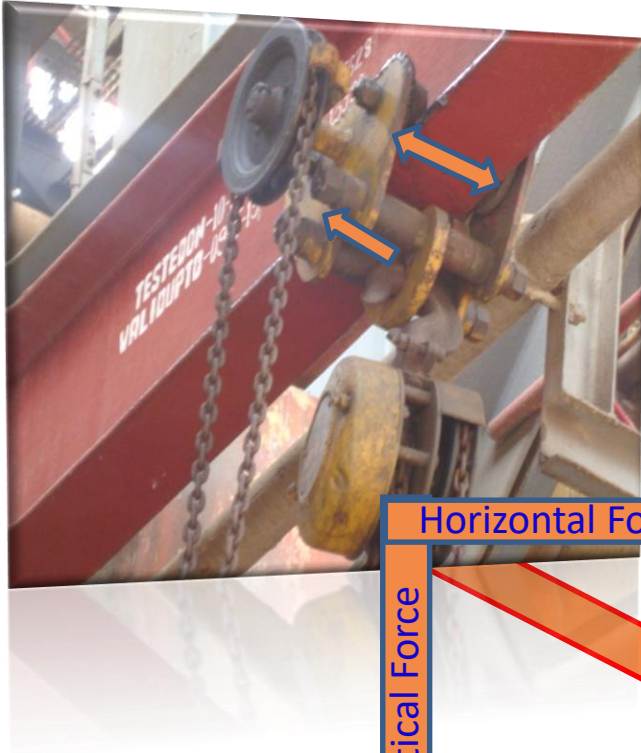
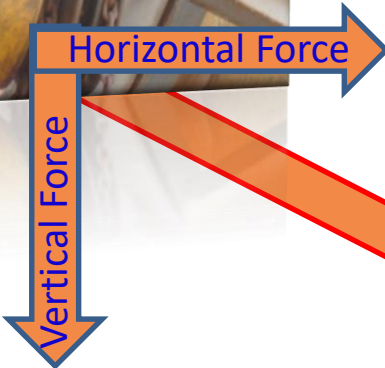
Pulling of bundle at an angle to vertical position

Failure Analysis

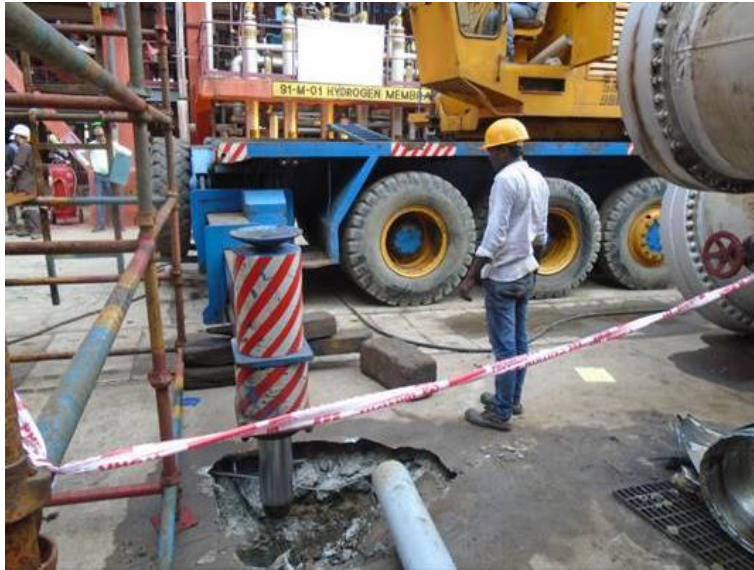
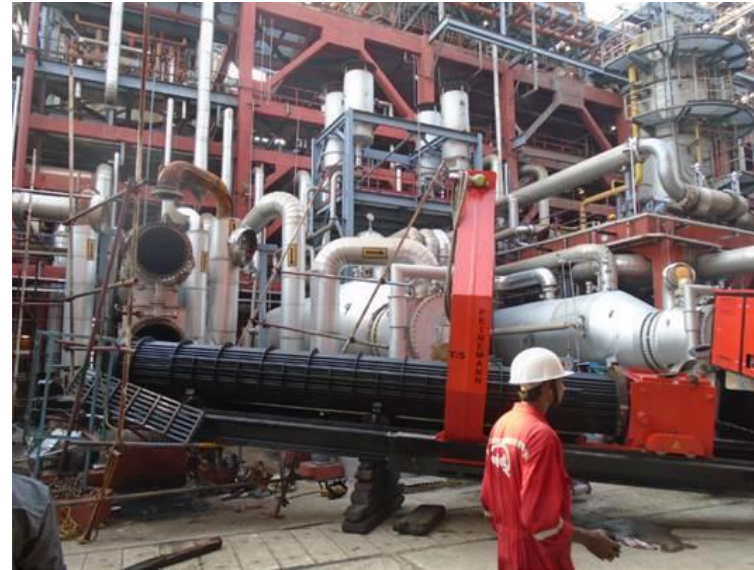
Outrigger of Crane got Depressed into the Ground

Incident : while one crane was lifting bundle puller carrying exchanger tube bundle, suddenly its rear right side outrigger, which was resting near the other exchanger , got depressed into the ground causing the crane to tilt ; luckily the crane did not overturn.

Lessons Learnt: As a practice metal base plates are to be placed below the outriggers for proper load distribution

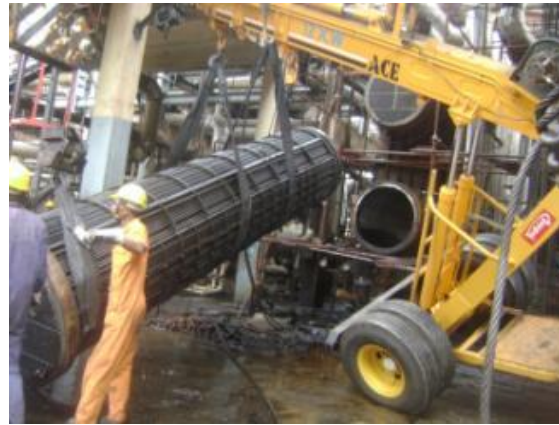
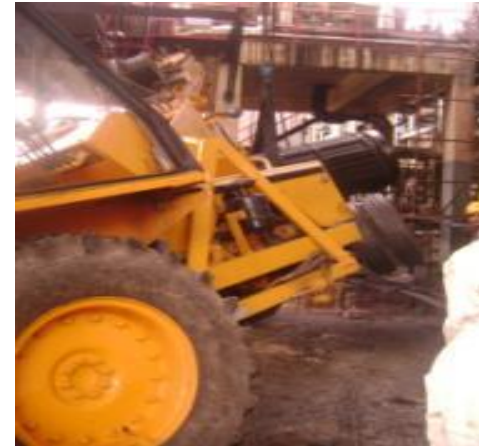
On Wednesday 15th July 2013 about 03:45 Hrs in Feed Preparation Plant-2 (GHC) Exchanger (03-EE-103D) tube bundle removal job was going on with the help of 2 hydras.

While removing tube bundle, it was supported by two hydras at each end of bundle. One of the hydra was pulling the bundle with little bit more speed than other hydra (GJ-6 AP 9357). Due to heavy unbalanced load, the exchanger bundle and hydra (GJ-6 AP 9357) was tilted.

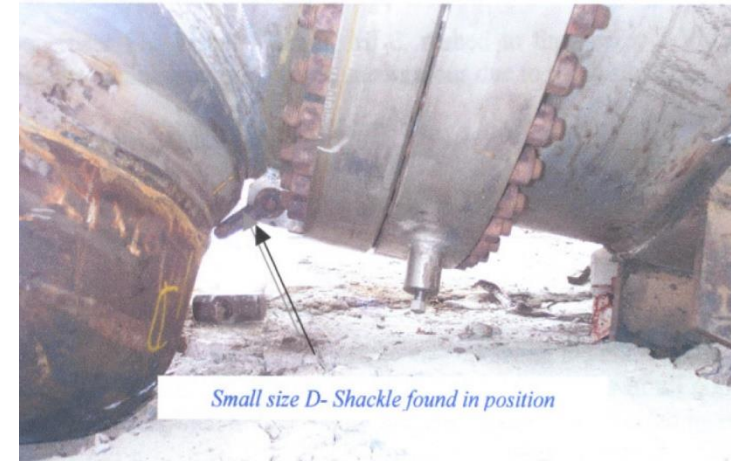
Small size D- Shackle found in position

One D- Shackle of about 2 tones capacity found in position

- EIC to ensure availability and use of certified lifting tools & tackles before execution of the work. A copy of the certificate may be retained with EIC.
- Erection plan for critical jobs may be made more comprehensive considering feasibility w.r.t. site condition & equipment involved.

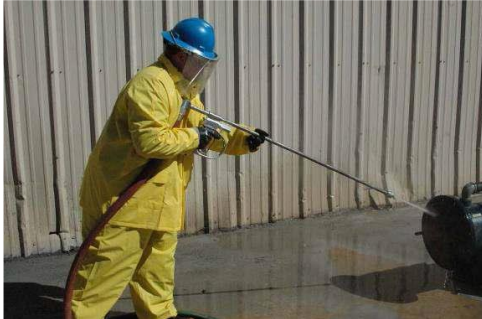
Shotgun with single dump valve

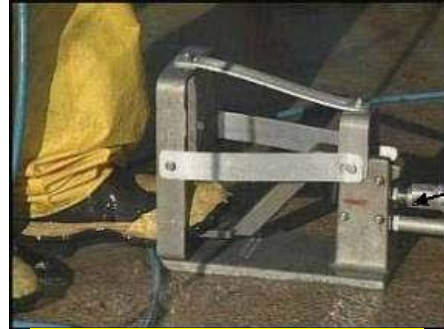
Typical foot-operated valve

Diffused water must be discharged away from personnel

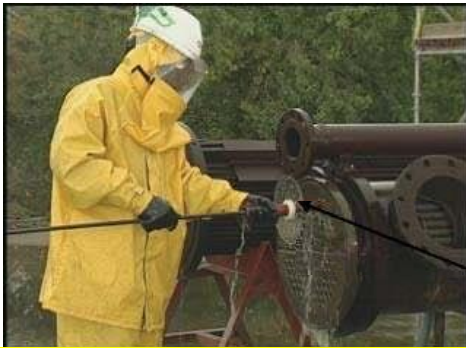
Typical anti-withdrawal device for stiff lancing

Deflector sized to permit free sliding fit for the pipe, but small enough to prevent the nozzle from passing the end in stiff lancing operation

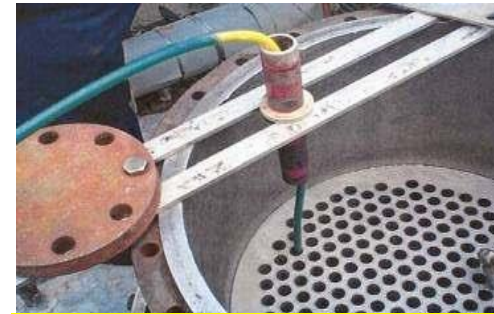
Typical anti-withdrawal device for flex lancing

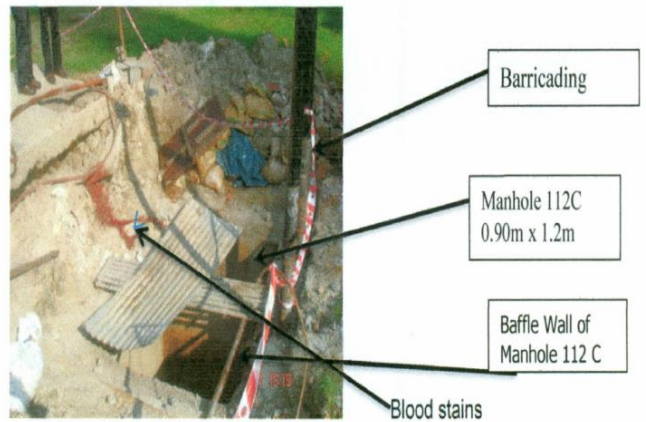
Photograph of Accident site

Date & Time	Incident	Root Cause	Lessons Learnt
01.10.2015 15:20 hrs.	Fatal accident of one contractor worker at PR while dechoking OWS by hydro-jetting machine.	Lack of coordination between Hydro-jetting machine operator and person (victim) holding the hose.	<ul style="list-style-type: none"> ➤ Pressure control of hydro jetting should be with the person holding the hose. ➤ Before awarding specialized outsourced jobs the Work Order should seek SOP and safety related process for undertaking the work. ➤ Comprehensive Job Safety Analysis shall be done for all outsourced and specialized jobs.

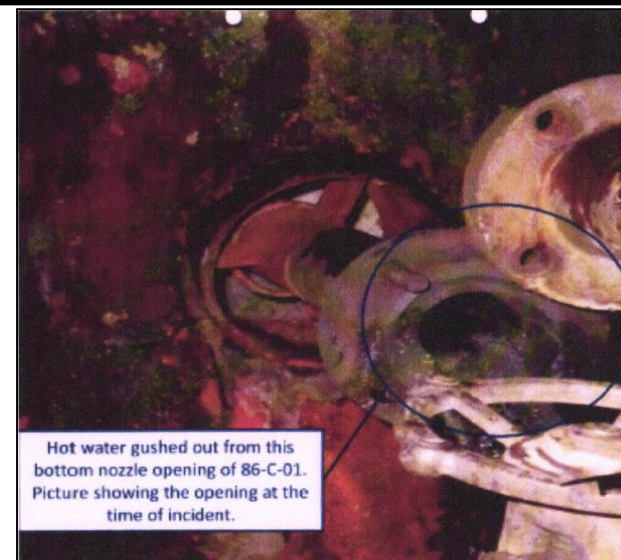
❑ **Brief of the Incident :** While dechoking 3" bottom outlet nozzle of wash water quench column (86-C-001) at TGTU by poking with a metal rod, hot water gushed out from the nozzle and spilled resulting in burn injury to two contract workers engaged in dechoking job. One of the workers (Mr. Baijnath Prasad of M/s P.K.M. Erectors) succumbed to burn injury on 30.08.2018.
