PNGRB Knowledge Sharing Workshop

Safety during Shutdown & Startup

By : Mr. B K Panda, Head of Safety, Paradip Refinery

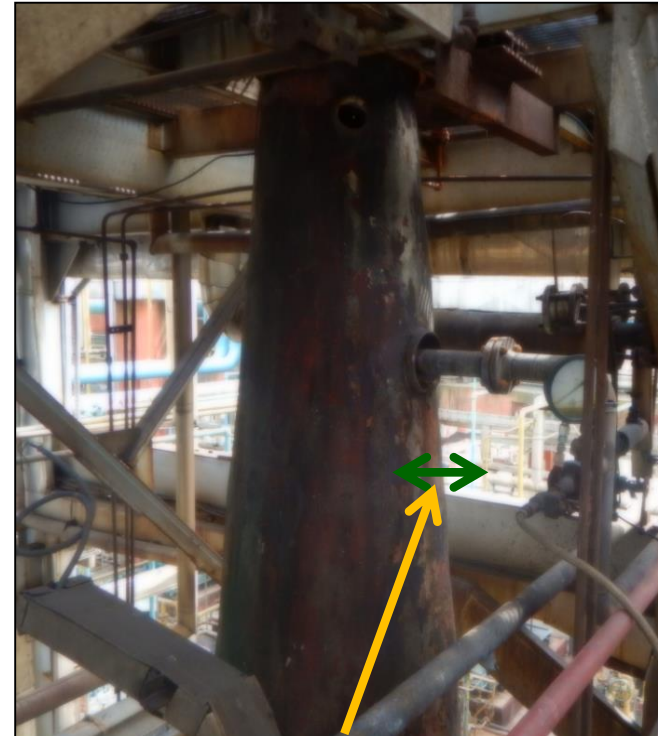
This portion was checked physically and found clear. To ensure thoroughness at elbow also, planned to put an L-shaped rod through the nozzle.

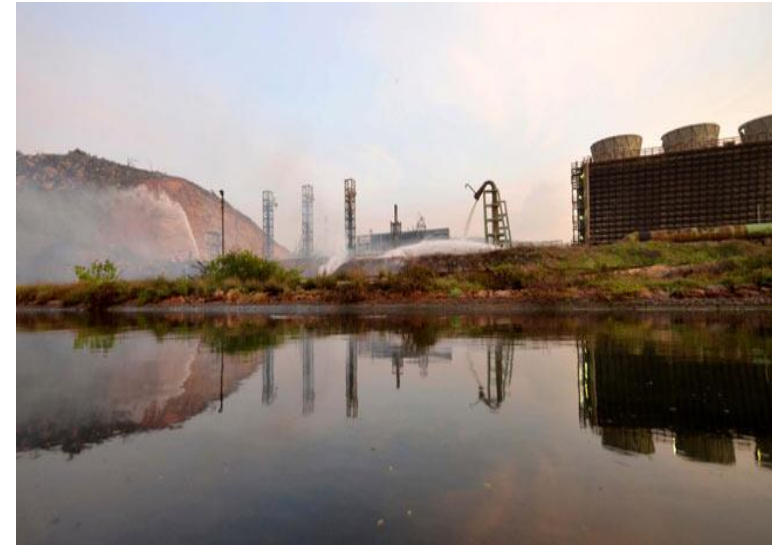
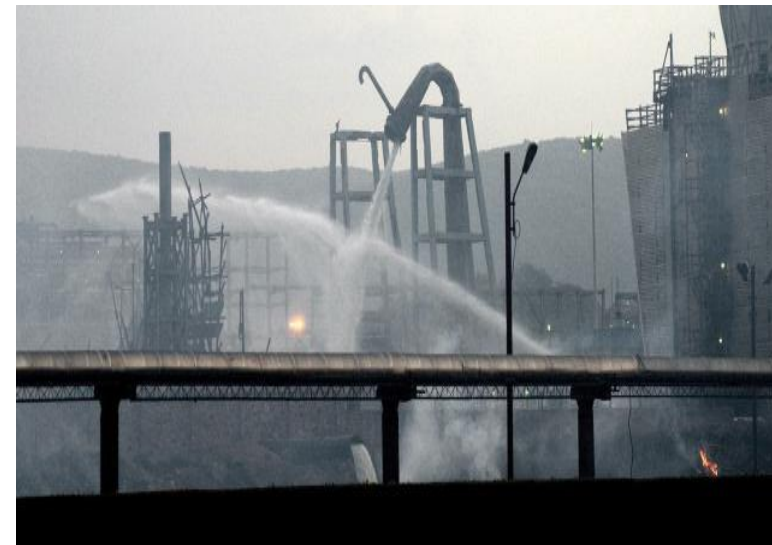
On 23-08-2013 there was a major fire at Visage Refinery of HPCL at Vishakhapatnam. The fire was in the newly constructed cooling tower.

The OISD investigation committee had noted a number of lapses which lead to the accident and had given some recommendations.
