Integrity of Old steel pipes

Ankleshwar – Valia Pipeline, Bharuch District, Gujarat

2nd Knowledge Sharing Workshop for CGD entities

14th February 2022

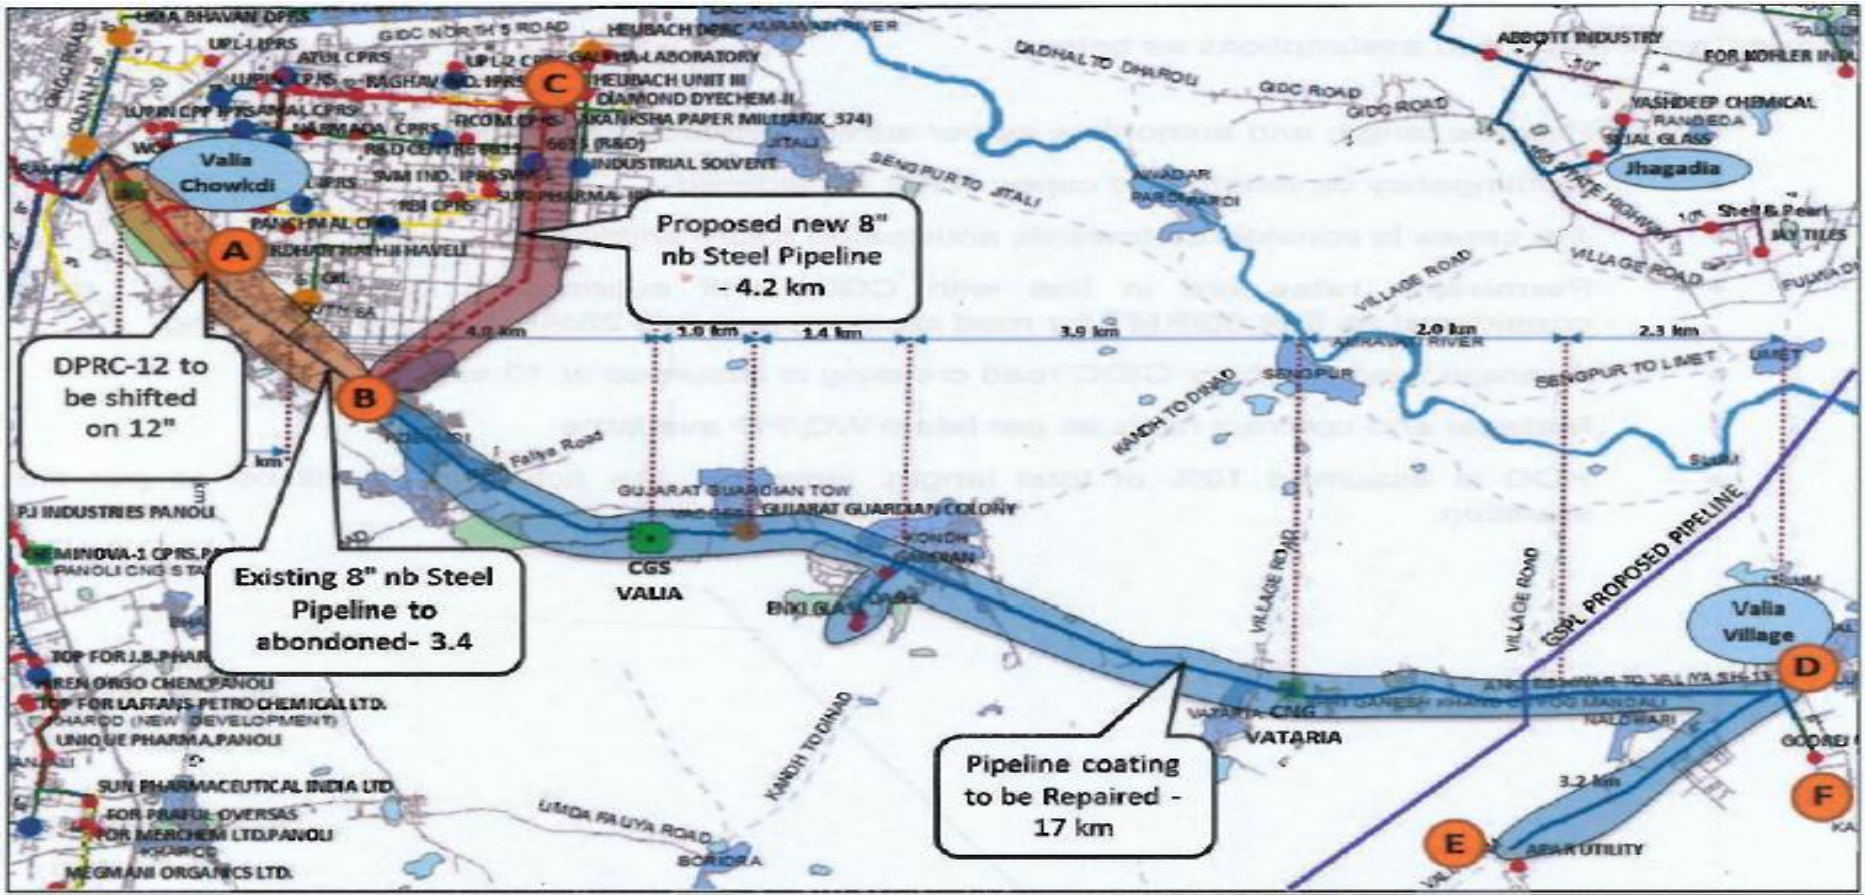
Option 3 i.e. Partial replacement of pipeline and partial coating refurbishment (8" Pipe Coating Refurbishment ~17 km (80%) and 8" Pipe section replacement ~4.20 km (20%))
