THIRD PARTY DAMAGE OF DVPL-I

- Emergency Management & Restoration

Location : Noida
Date : 15 June 2022

GAIL India Limited

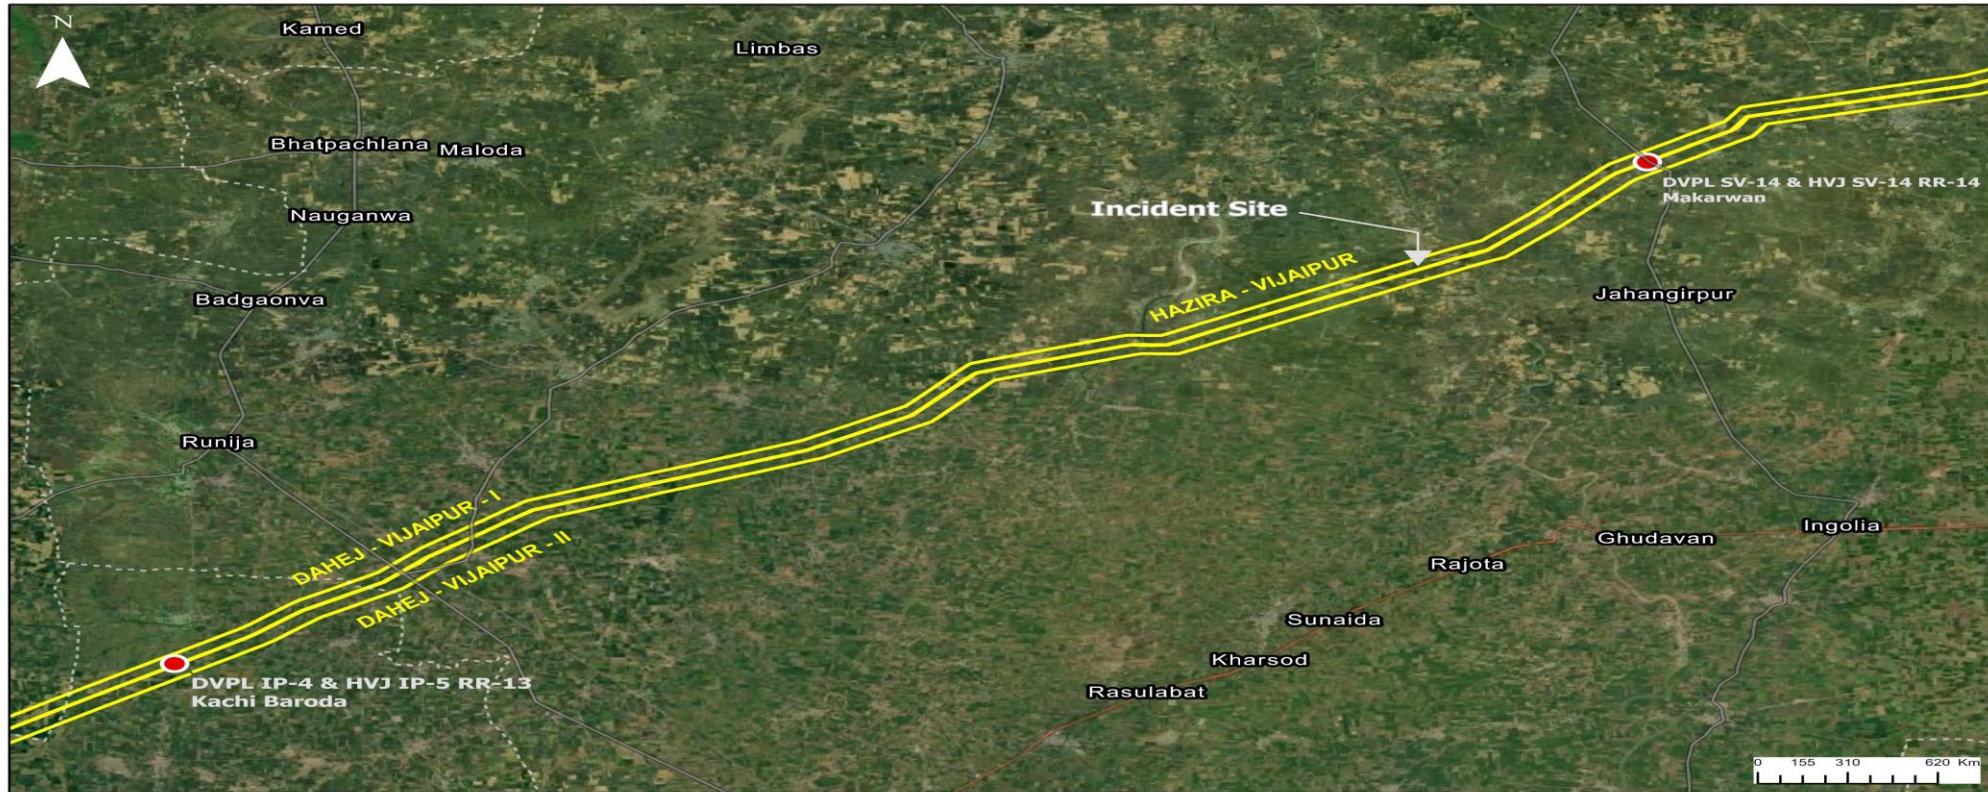
Case Description

S.No	Parameter	Details
01.	Name of the Pipeline	42" Dahej – Vijaipur Pipeline (DVPL-I)
02.	Length of the Pipeline	611.64 km
03.	Design Pressure	92 kg/cm ²
04.	Operating Pressure	84 kg/cm ²
05.	Right of Use (RoU)	48 m wide common ROU for 36" Hazira-Vijaipur Pipeline, 42" & 48" Dahej-Vijaipur Pipelines
06.	Chainage of the Incident Location	377.38 km
07.	Other Pipelines in the Vicinity	BORL's [Bharat Oman Refinery Limited] Pipeline at approx. 100 m from ROU
08.	Incident Type	Heavy Gas Leakage (Jet Leak without Fire)
09.	Cause	Third Party Damage → Borewell Digging
10.	Reported Time of Incident	08:40 AM
