# PNGRB KNOWLEDGE SHARING WORKSHOP 2023

## CASE STUDY ON SR LINE LEAK IN CDU-III UNIT OF VR

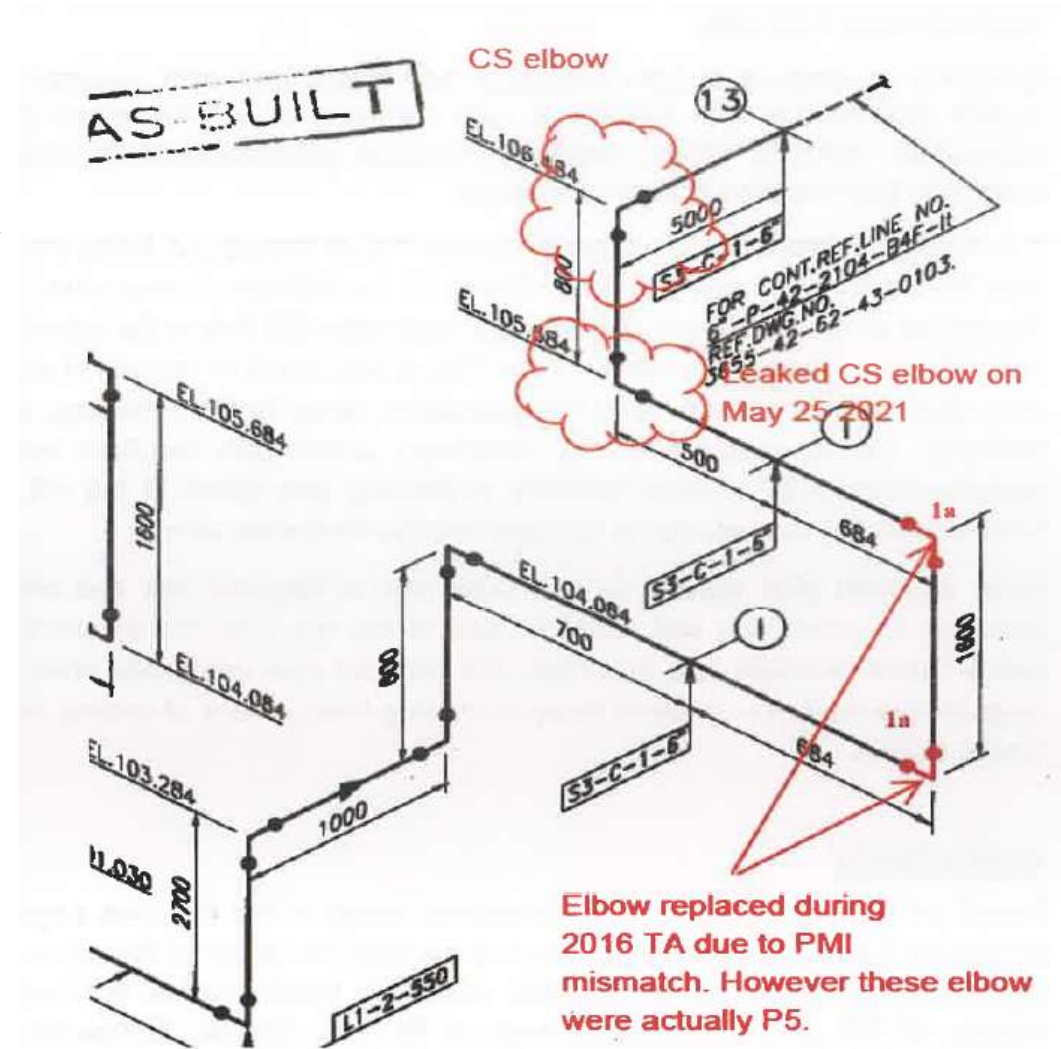
- SR leak from the failed CS elbow and subsequent auto ignition.
- The material of construction of the failed elbow (CS metallurgy) does not meet the intended design specification of P5 metallurgy required for high temp and high corrosive service (SR).
- The rupture opening of the CS elbow occurred due to severe thinning caused by localized corrosion.

- The said two CS elbows were installed by mistake during Projects execution in 1999.
- During 2016, two separate isometrics were used by PMI and UTG agencies. Subject two elbows were identified as CS and marked on the PMI isometric.
  - A different set of two adjacent elbows were inadvertently marked while transferring from the PMI isometric to UTG isometric and attached with Inspection recommendation.
  - Wrong marking resulted in replacement of two P5 metallurgy elbows instead of identified CS elbows. One of these CS elbows failed leading to the subject incident.

- Revised Inspection SOP is put in place to ensure usage of correct metallurgy at fabrication stage and during repairs.
  - Implemented Four stage PMI checks: 1) At Vendor site by HPCL TPI; 2) At Warehouse; 3) At Fit-up stage and 4) Before Hydro test.
  - PMI and UTG related Inspection recommendations are issued with separate isometrics.
  - Joint certification by Inspection and Executing department is established to ensure correct metallurgy usage at original fabrication/replacement stage.
- Integrity operating windows (IOW) for critical circuits are developed and implemented in line with API RP 584.
