Knowledge Sharing Workshop on Petroleum Refineries by PNGRB & HPCL

CASE STUDY ON INCIDENT AT ISOM UNIT OF IOCL-HALDIA REFINERY

Visakhapatnam, 27th February 2023

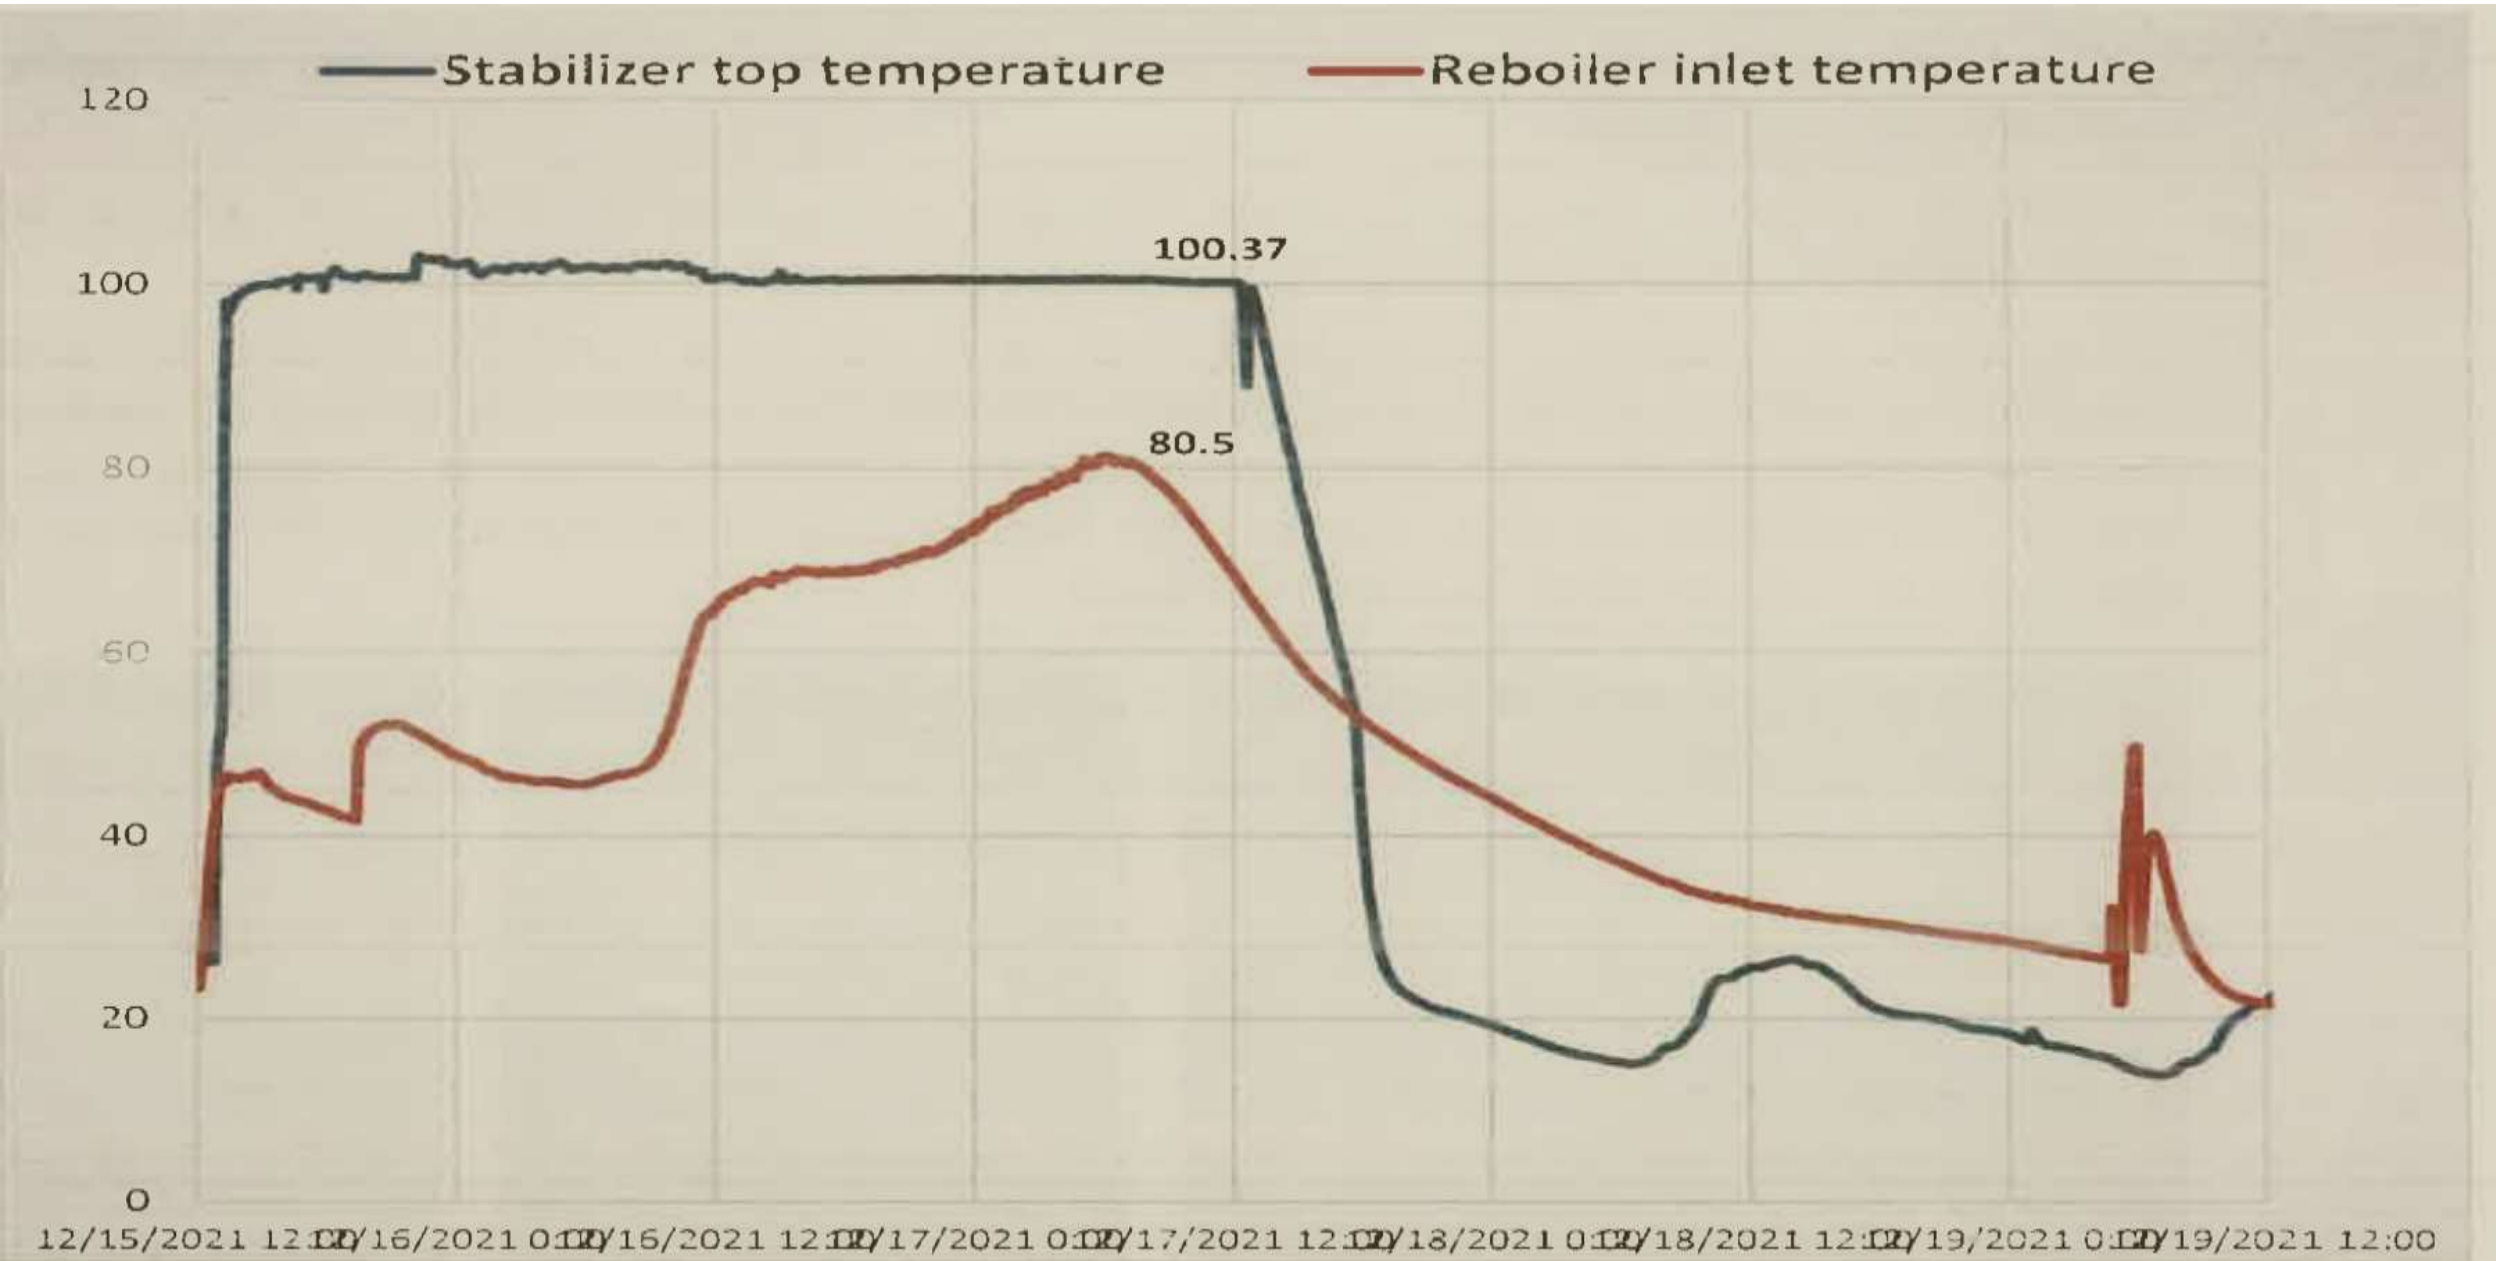
CHRONOLOGY OF EVENTS

- During the flange opening activity for blinding of 86-E-06 inlet flanges, naphtha started coming out of the flanges.
- At 14.50 hrs, there was an explosion followed by fire leading to fatality of 3 contract workers and injury of 41 persons [from FIR].

- The column bottom has a partition and two outlets (from each partition). One outlet goes to the 86-B-06(Chloride Guard) and the other partition outlet goes to the thermo symphonic Reboiler (86-E-06, Stabilizer reboiler).

- Also, during the site visit of the committee on 22.12.2021 morning at 10.30 hrs the drain valves were found in open condition.
- While checking on 24.12.2021 for Naphtha hold up in the reboiler circuit by adding water from the reboiler outlet line, it was observed that the reboiler circuit was still filled with light naphtha.

1. Dechoking of drain line and revisioning / replacement of suspected 1st drain valve of the reboiler circuit of 86-C-01(Stabilizer column) / 86-E06(Stabilizer reboiler).
